Onsite measurements of concrete structures using Impact-echo and Impulse Response

ABSTRACT: Concrete structures deteriorate, often unnoticed, in worst case the damages are not visible until it is too late for a repair or the repair will be extensive and costly. New structures may have defects from the execution compromising durability and safety. The use of NDT (Non Destructive Testing) can provide valuable information of the condition of a concrete structure and can be a valuable help when planning the maintenance of a structure. NDT can further be used during the construction phase for quality assurance of a structure. Hidden faults can be detected early and can be remedied while access to the structure is still possible without major inconvenience. Special inspections combining a visual survey with NDT techniques can disclose problems at an early state and provides valuable information of the actual condition of the structure. The use of NDT should not be used to evaluate a structure without a thorough calibration of the equipment onsite e.g. by drilling out a limited number of cores.

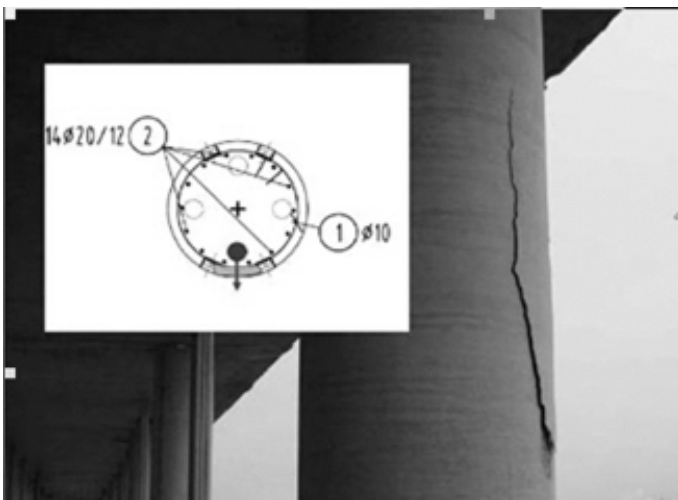
A few days after a period with cold weather and temperatures below 0°C in January 2008, cracks and spalling started to appear suddenly on columns in a new 8-story office building, which was still under construction. A visual inspection revealed the presence of cracks and spalling in 29 out of 489 columns distributed on 6 floors with 13 of the damaged columns on Level 4. The cracks were mainly visible at the tops of the columns and always directly in front of one of the four the cable ducts in each column. Figure 7 shows a column with spalling and the sectional view of a column shows one of the cable ducts highlighted with a solid circle.

Figure 7. Photo of a column with spalling and a sectional view of the column.

The cracking and spalling can be explained by the presence of water in the ducts, which froze during the few days with temperatures below 0°C and hence expanded. Construction photos from casting of the floors showed the drainage of the formwork let the water directly to some of the columns.

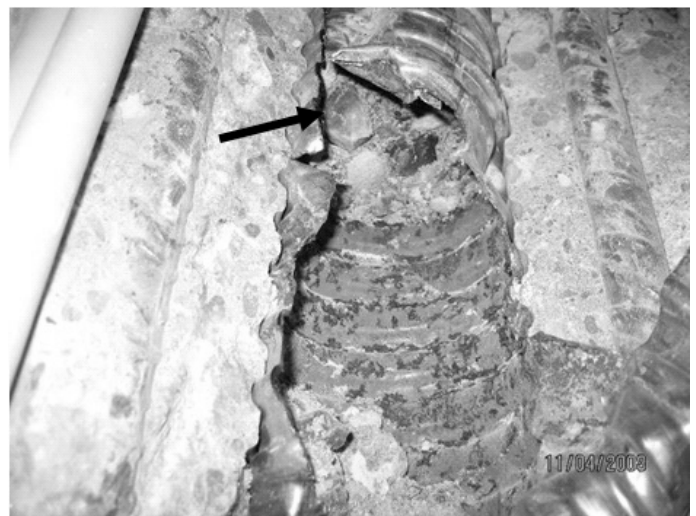
A not expected discovery was the presence of larger aggregates in the “mortar”. Breaking up the ducts revealed the presence of aggregates with a diameter up to 32 mm. The “grout” in the ducts was the same concrete as has been used for casting each floor and not the prescribed mortar mixture. With a 25 mm reinforcing rebar in the centre of an 80 mm duct, the chance of having a blocking due to the large aggregates is high and explain the presence of voids and partly filled ducts. See the photo in Figure 8.

Figure 8. The presence of large aggregates and air voids were revealed during breakup of a duct.

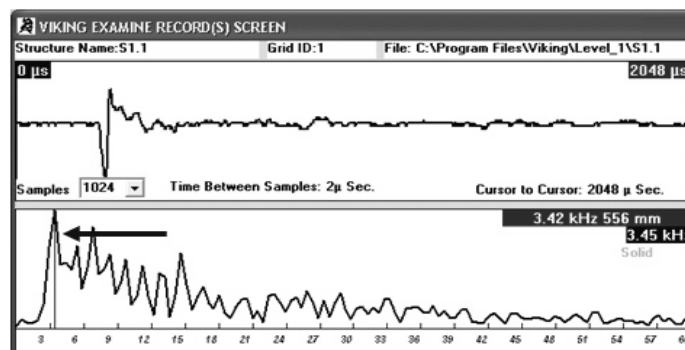
Figure 11. Frequency peak (arrow), which corresponds to the thickness of the column.

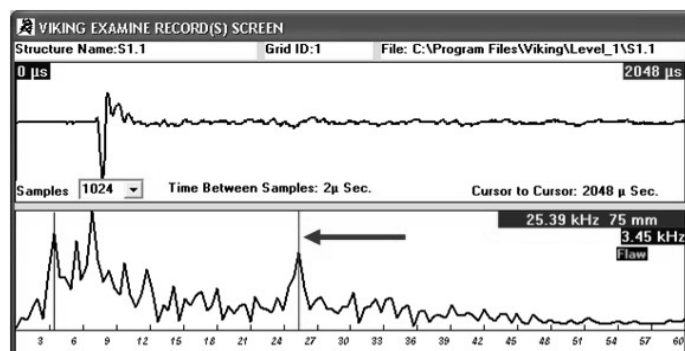
Figure 12. Frequency peak (arrow) due to the presence of air in the duct at a depth of 75 mm.

The investigations showed that almost 10 % of the ducts at the bottom of the columns and 33 % at the top of the columns were empty. 4 % of the tests were classified as “uncertain” and could be both loose gravel/aggregates or an empty duct.

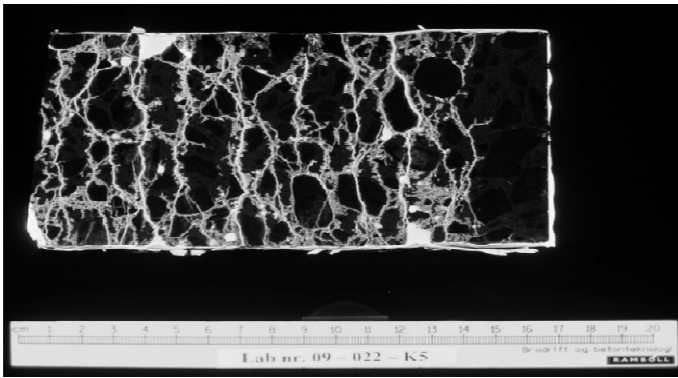
Figure 13. 100 mm core, vacuum impregnated with epoxy and exposed to UV-light.

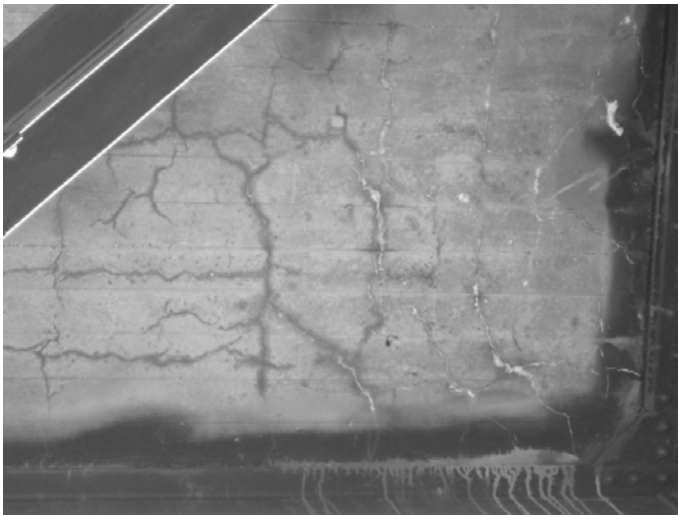
The extend of ASR, which can be seen from the underside, was most evident adjacent to the joints – but also in other local areas - where there were signs of cracks and moisture permeation. See example in Figure 14.

Figure 14. Close-up of the underside of the bridge deck. Moist cracks and white precipitations are visible.

If there are signs of ASR on the underside of the bridge deck the concrete is damage throughout the cross section of the bridge deck as ASR starts on the upper surface and penetrates down through the concrete as long as moisture is available. ASR will stop as soon as the influx of water stops.

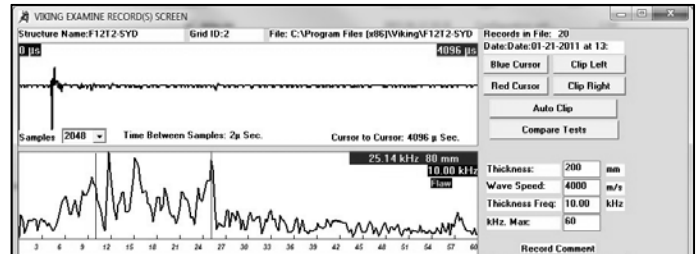
Figure 16. IE - ASR-signal with measured thickness of 80 mm (from the bottom of the bridge deck and upwards).

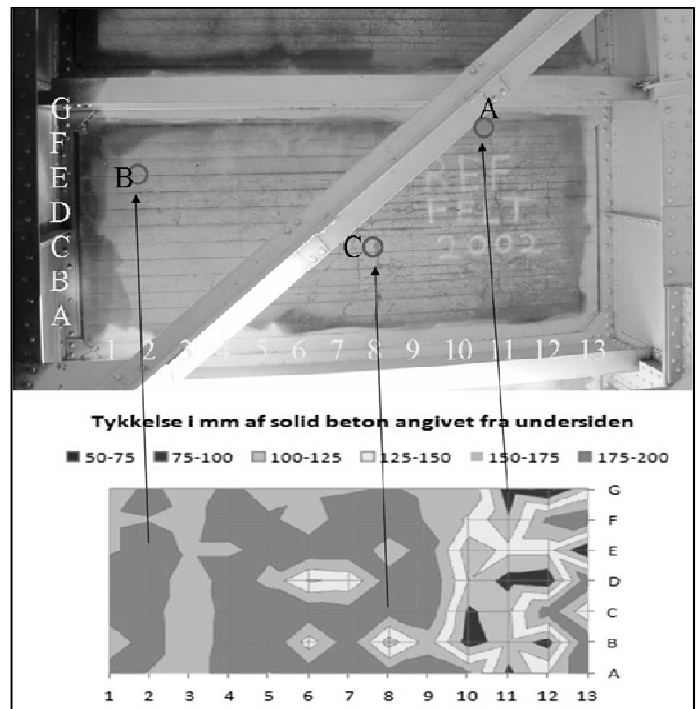
Testing was performed in a grid of 25 cm x 25 cm – approx. 6 m². The results indicate some local areas with reflections from a depth of 125 mm between column 6-8 in row B and D and a large area between columns 10-12 from row A-G with reflections between 75-125 mm. Se Figure 17.

Three cores were drilled out for calibration, Core A, B and C. Core A showed signs of cracks 80 mm from the underside of the bridge deck. B and C were solid.

Figure 17. Photo of tested area with data presented as a contour plot below. Dark colors indicate shallow reflections from cracks.

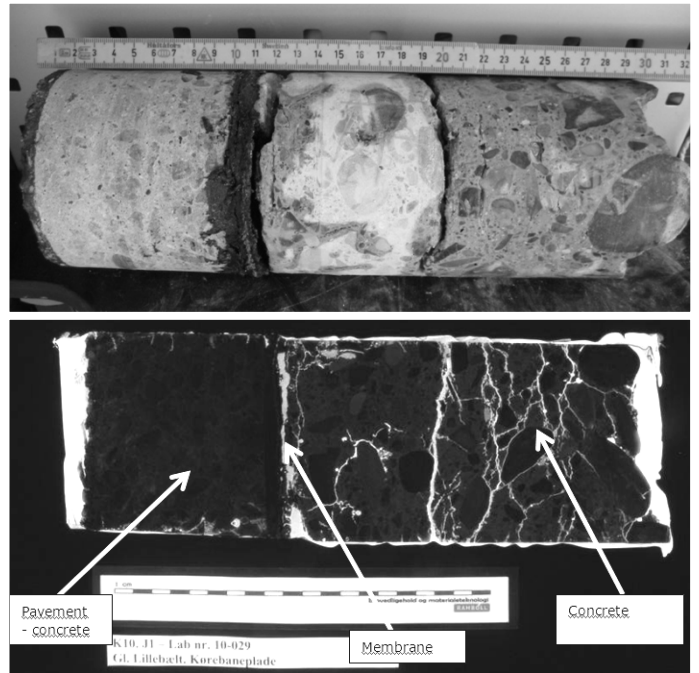
A photo of a core after drilling and after it has been vacuum impregnated with epoxy is shown in Figure 19. The top of the core faces left. The ASR cracks are clearly visible on the lower photo.

Figure 19. Photo of core after is has been drilled out and after vacuum impregnation with epoxy and exposed to UV light.

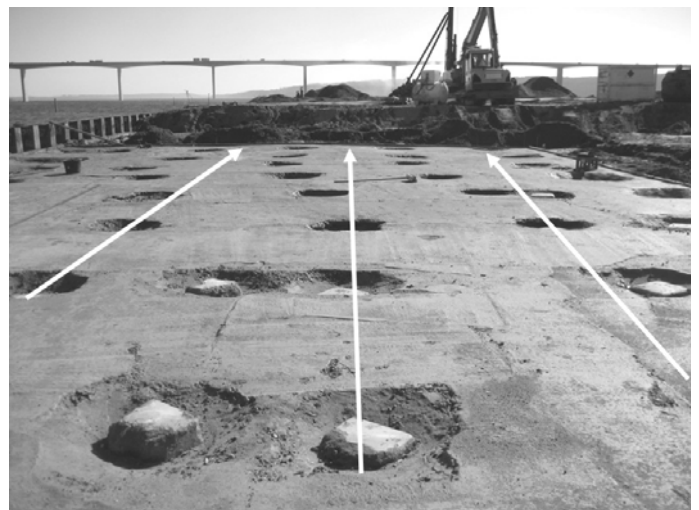
After some time it was discovered that the top of several piles - within a restricted area - between row 30-34 and module lines A-E, had moved up to 0.7 m horizontally. Consequently the piles were suspected to be broken.

In Figure 20 is a photo showing how the piles are shifted to one side. The white lines indicate the lines C, D and E. It is evident that the piles furthest away from the photo have moved most towards left.

Figure 20. Photo of piles, which are moved up to 0.7 m towards left. The arrows indicate the original location of the piles.

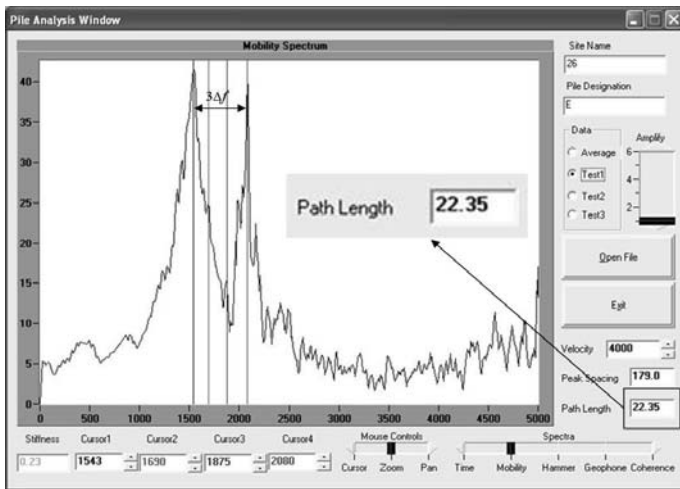
Figure 21. Mobility diagram from testing an 11 m long pile.

The wave velocity was set to 4,000 m/s and was not measured directly on the piles. A total of 68 piles were checked within a few hours. 15 of the piles, which should be 11 m long, had indications of flaws at depths between 7.6 - 10.6 m from the top.
