Onsite measurements of concrete structures using Impact-echo and Impulse Response

Inspection Specialist, Ramboll Denmark A/S, Copenhagen, Denmark

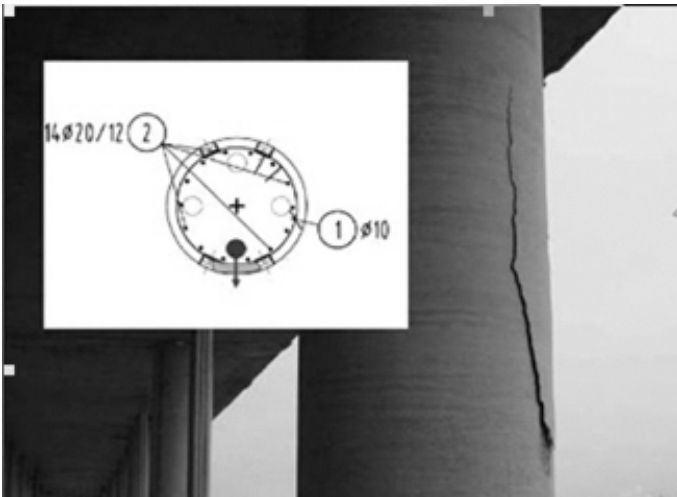
A few days after a period with cold weather and temperatures below 0°C in January 2008, cracks and spalling started to appear suddenly on columns in a new 8-story office building, which was still under construction. A visual inspection revealed the presence of cracks and spalling in 29 out of 489 columns distributed on 6 floors with 13 of the damaged columns on Level 4. The cracks were mainly visible at the tops of the columns and always directly in front of one of the four the cable ducts in each column. Figure 7 shows a column with spalling and the sectional view of a column shows one of the cable ducts highlighted with a solid circle.

Figure 7. Photo of a column with spalling and a sectional view of the column.

The cracking and spalling can be explained by the presence of water in the ducts, which froze during the few days with temperatures below 0°C and hence expanded. Construction photos from casting of the floors showed the drainage of the formwork let the water directly to some of the columns.

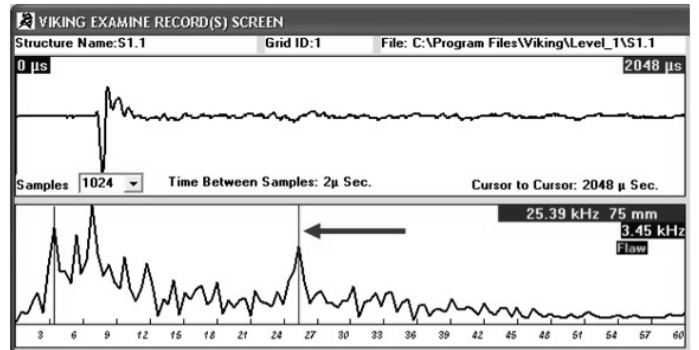
Figure 12. Frequency peak (arrow) due to the presence of air in the duct at a depth of 75 mm.

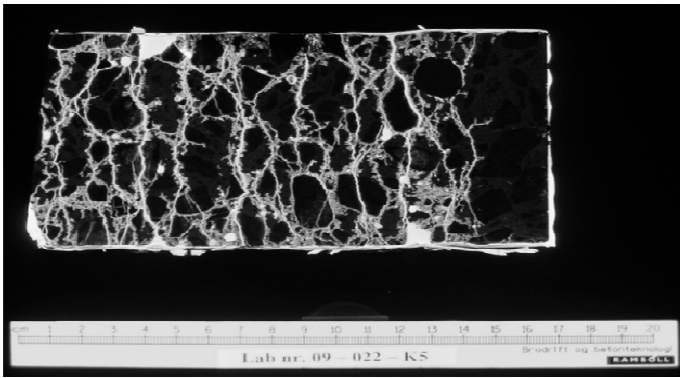
Alkali silica reaction (ASR) is a concrete durability problem whereby certain forms of silica in aggregates react in high alkaline pore solutions in concrete to form a reaction product that expands in the presence of moisture and results in deleterious cracking of concrete. An example of a concrete core with ASR is shown in Figure 13.

Figure 13. 100 mm core, vacuum impregnated with epoxy and exposed to UV-light.

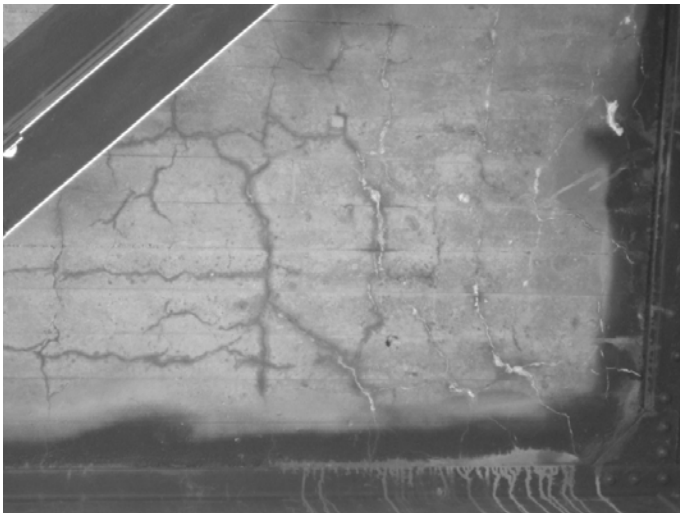
The extend of ASR, which can be seen from the underside, was most evident adjacent to the joints – but also in other local areas - where there were signs of cracks and moisture permeation. See example in Figure 14.

Figure 14. Close-up of the underside of the bridge deck. Moist cracks and white precipitations are visible.

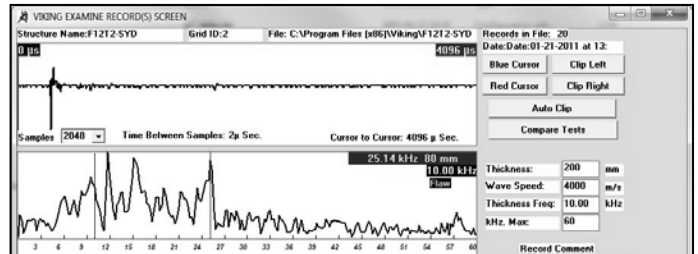
Figure 16. IE - ASR-signal with measured thickness of 80 mm (from the bottom of the bridge deck and upwards).

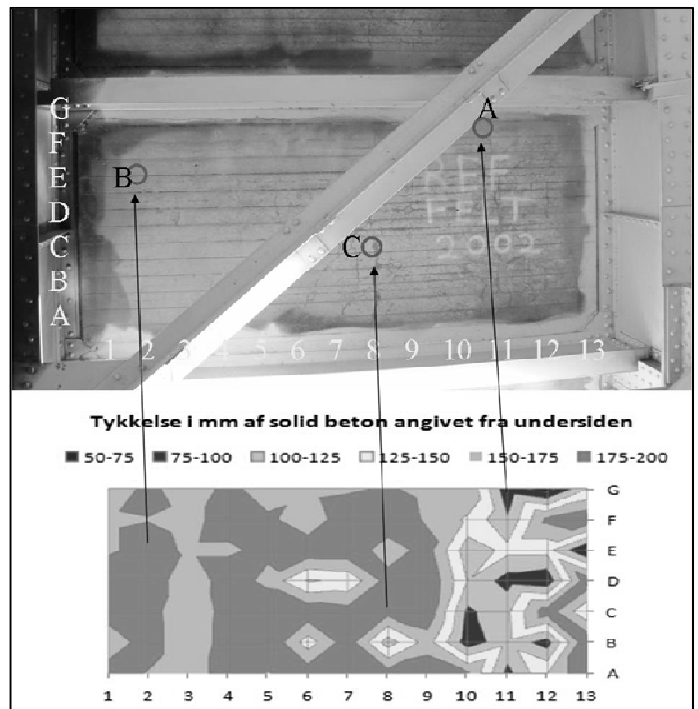
Testing was performed in a grid of 25 cm x 25 cm – approx. 6 m². The results indicate some local areas with reflections from a depth of 125 mm between column 6-8 in row B and D and a large area between columns 10-12 from row A-G with reflections between 75-125 mm. Se Figure 17.

Three cores were drilled out for calibration, Core A, B and C. Core A showed signs of cracks 80 mm from the underside of the bridge deck. B and C were solid.

Figure 17. Photo of tested area with data presented as a contour plot below. Dark colors indicate shallow reflections from cracks.

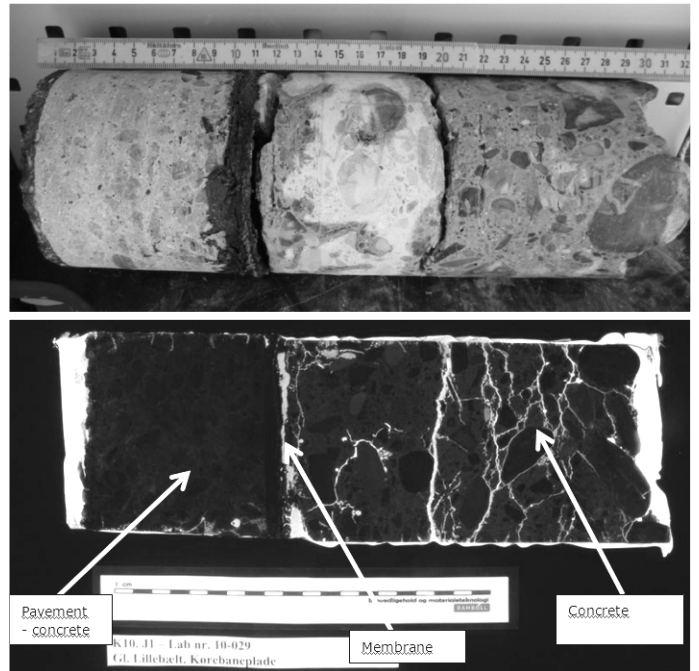
The test showed that the 10 cm thick pavement was intact in all the test areas. The problem was either poor adhesion of the membrane and concrete or cracks in the concrete below the membrane (ASR). With the IR it was possible to distinct between shallow defects or deeper defects.

A photo of a core after drilling and after it has been vacuum impregnated with epoxy is shown in Figure 19. The top of the core faces left. The ASR cracks are clearly visible on the lower photo.

Figure 19. Photo of core after is has been drilled out and after vacuum impregnation with epoxy and exposed to UV light.
