INJECTION QUALITY OF STEEL CABLE DUCTS EVALUATED BY NDT

Claus Germann Petersen^a

ABSTRACT

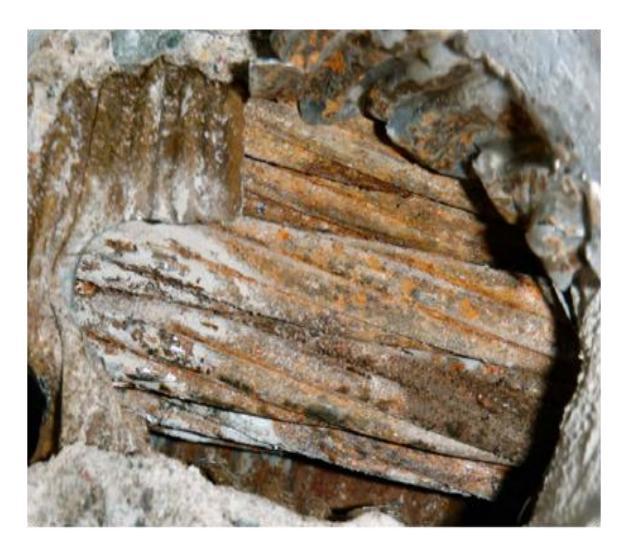
Fig.4 Corroded strands in empty steel duct

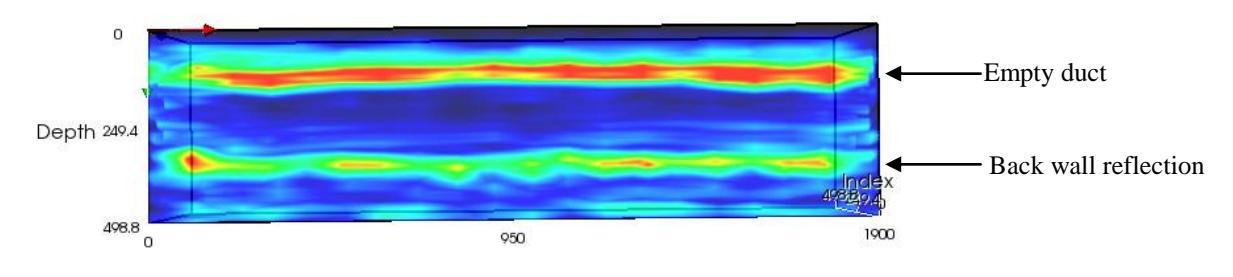
Fig.11. D-scan of the reflection from the empty duct

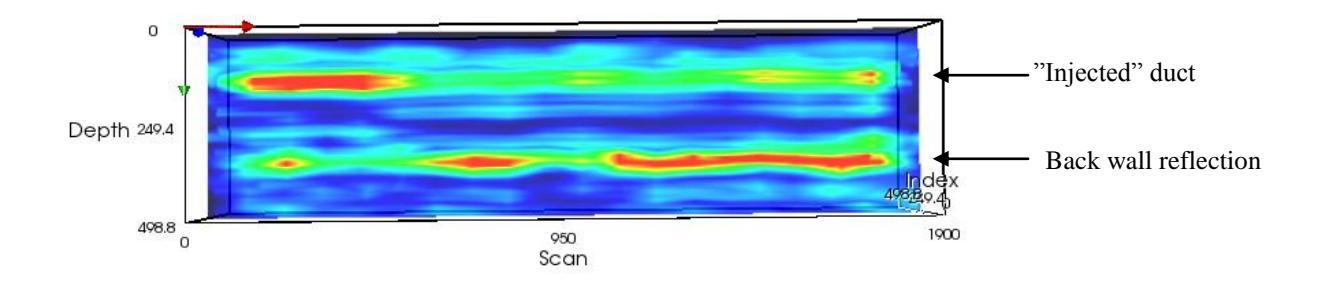
Fig.12. D-scan of the reflection from the "injected" duct

As will be seen from the figures, the "injected" duct is in fact not fully injected. Starting from the south face of the specimen and extending about 30 cm into the duct, the red reflection indicates air in the duct.

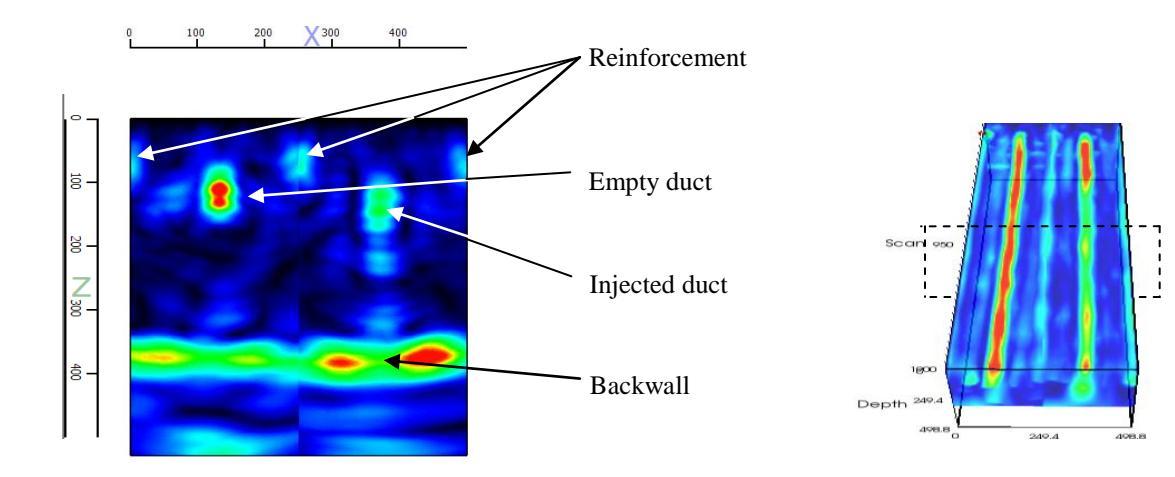
Fig. 13. B-Scan 1200 mm from south edge

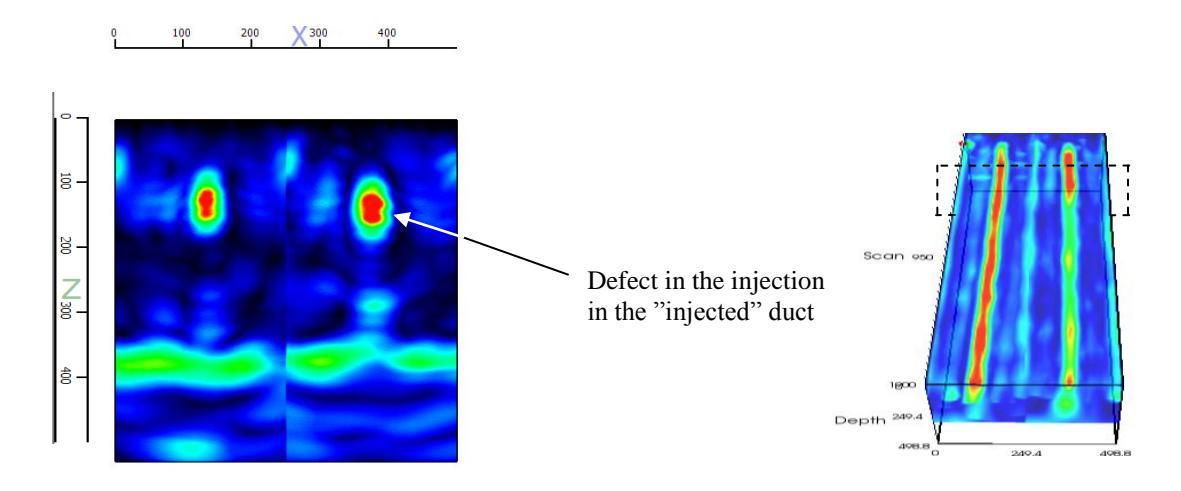
Fig.14. B-Scan 150 mm from south edge

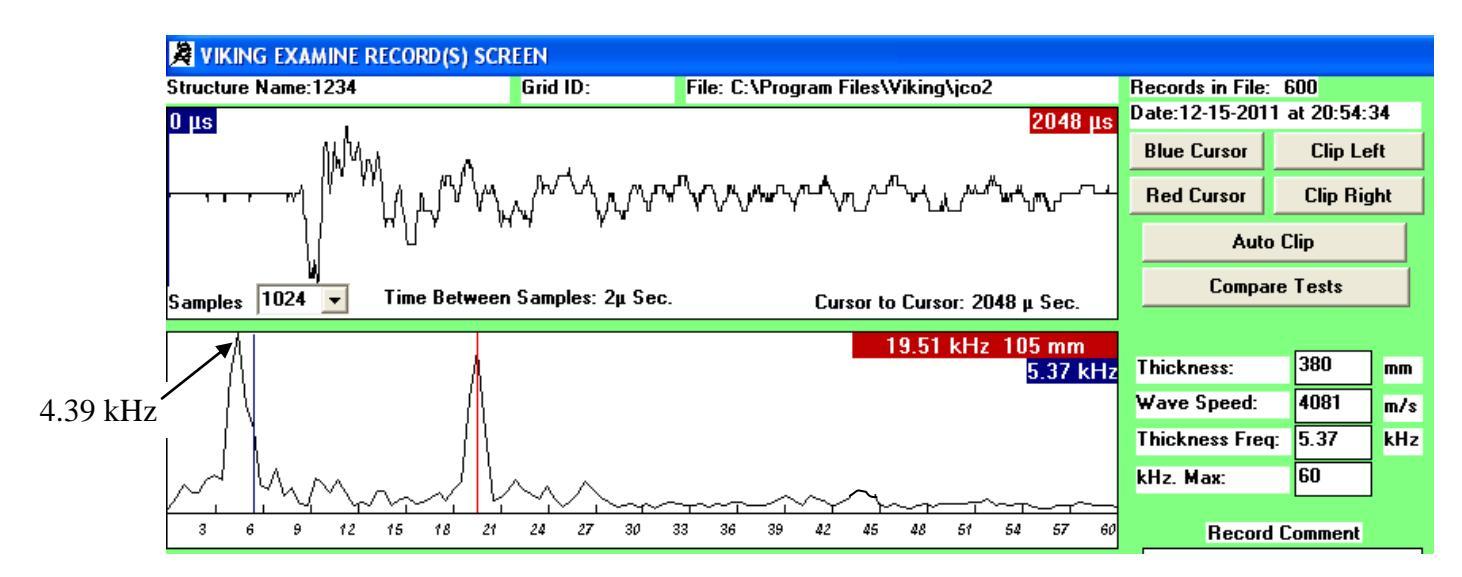
3.2.2 Point B, Empty Duct

Fig.17. The 5.37 kHz solid frequency in fig.16 has dropped to 4.39 kHz, meaning that the travel path of the P-wave is: (4081 m/s / (2 x 4.39 kHz))=464 mm, 84 mm longer than 380 mm. Consequently, the P-wave has to run around a reflection surface, which may be the empty cable duct. At the same time a frequency peak at 19.51 kHz shows up, where the red cursor is positioned. This frequency relates to a depth to the reflection surface of 105 mm, the depth of the empty cable duct.

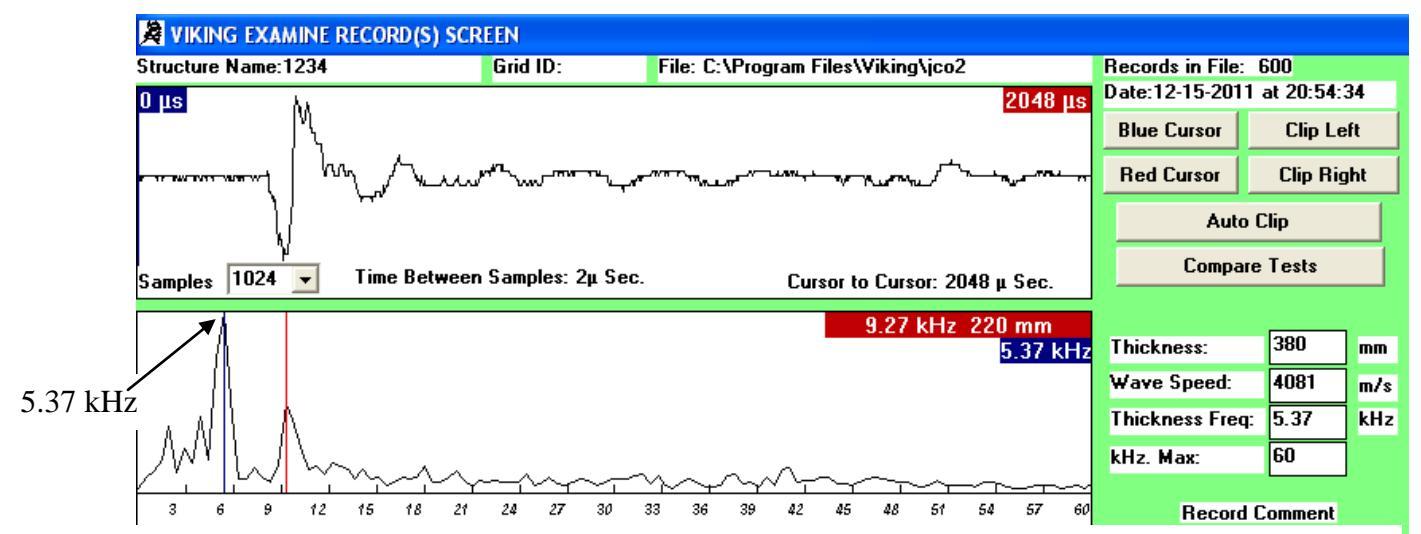
3.2.3 Point C, Fully Injected Duct

Fig.18. The 5.37 kHz frequency is the same as the solid frequency in fig. 16 indicating a P-wave travel path of 380 mm. This can only happen if the duct with the strands is fully injected with no air intrusions, provided the testing is made over the duct. To make sure this is the case, there has to be an additional reflection from the strands inside the injected duct. This reflection shows up at 9.27 kHz, equivalent to a depth to the steel strands at 4081 m/s / (4x 9.27 kHz) = 110 mm (half of the 220 mm indicated in the red box), the impact-echo equation for air / concrete / steel. An 8 mm impactor was used. To enhance the 9.27 kHz peak a 5 mm impactor was subsequently used, fig. 19.

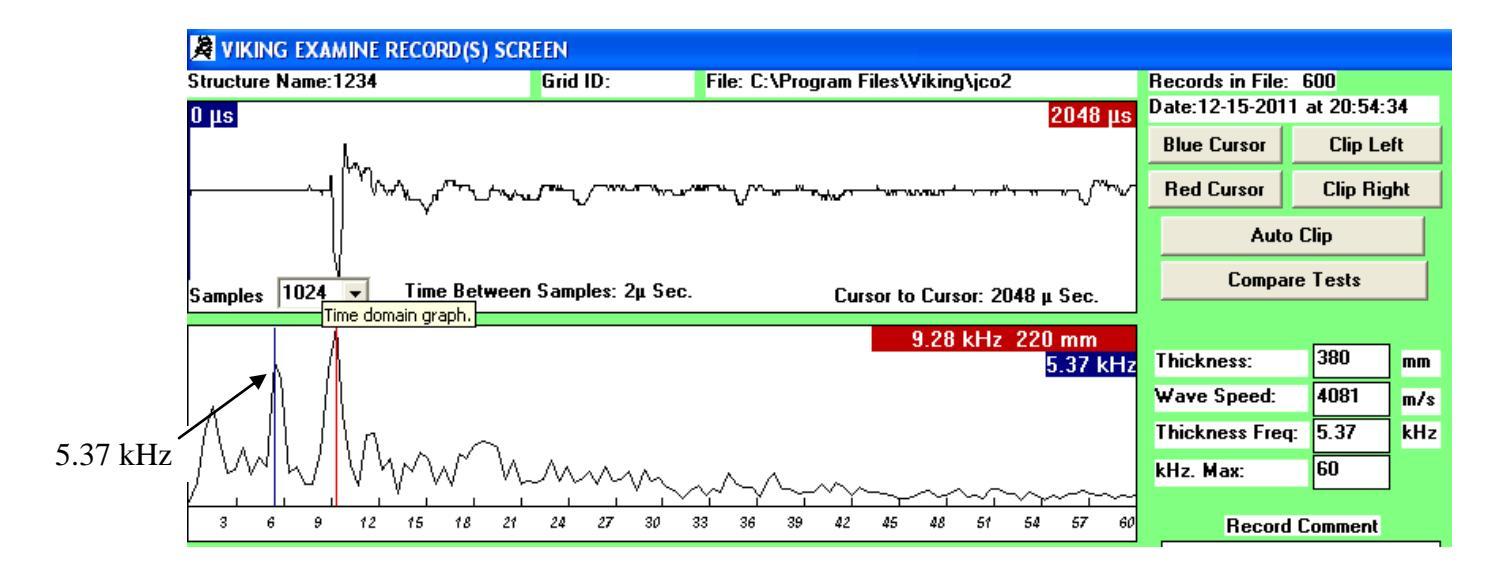
Fig.19. Enhancement of the signal in fig. 18. A 5 mm impactor is used with a smaller contact time producing a higher maximum useful frequency. The main conclusion is the same: As the solid frequency of 5.37 kHz in fig. 10 is unchanged the P-wave runs directly through the duct with no obstruction from air interfaces inside the duct. In addition, a more pronounced frequency peak at 9.28 kHz is exhibited, producing a depth to the steel strands inside the cable duct of 4081 $m/s / (4 \times 9.27 \text{ kHz}) = 110 \text{ mm}$, following the impact-echo equation for air / concrete /steel.

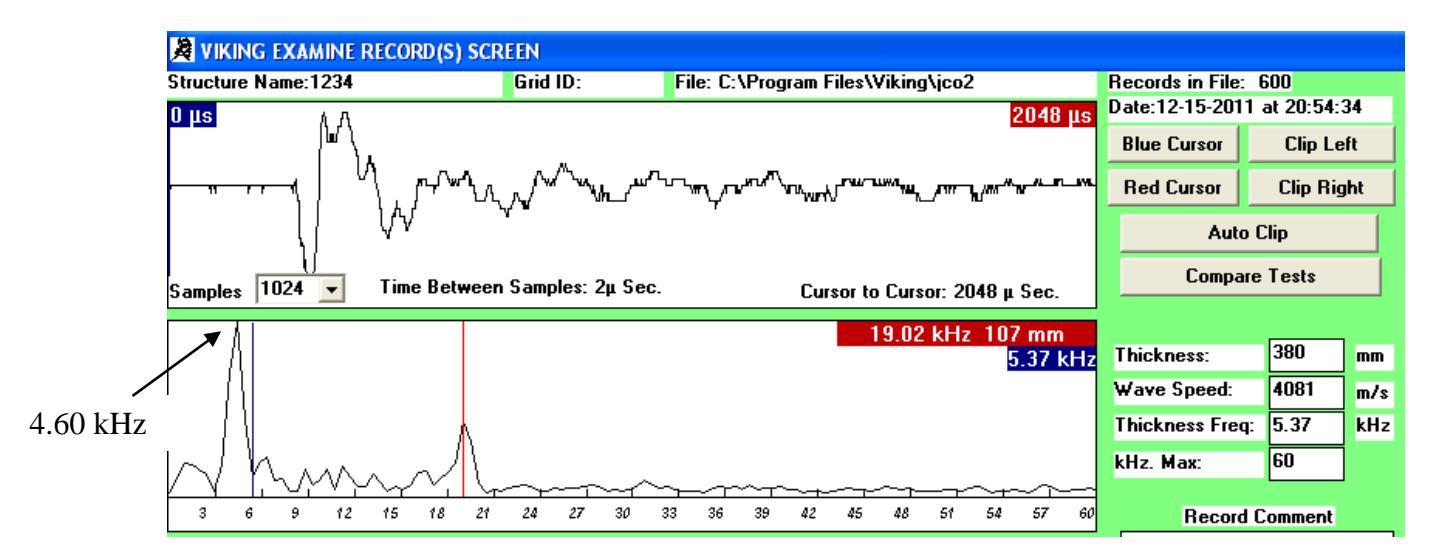
3.2.4 Point D, Poorly Injected Duct

Fig.20. The P-wave has a travel path of more than 380 mm as the frequency has dropped from 5.37 kHz to 4.60 kHz. This can only happen if there is air in the duct. The air interface is positioned at a depth of 107 mm. The duct is poorly injected.

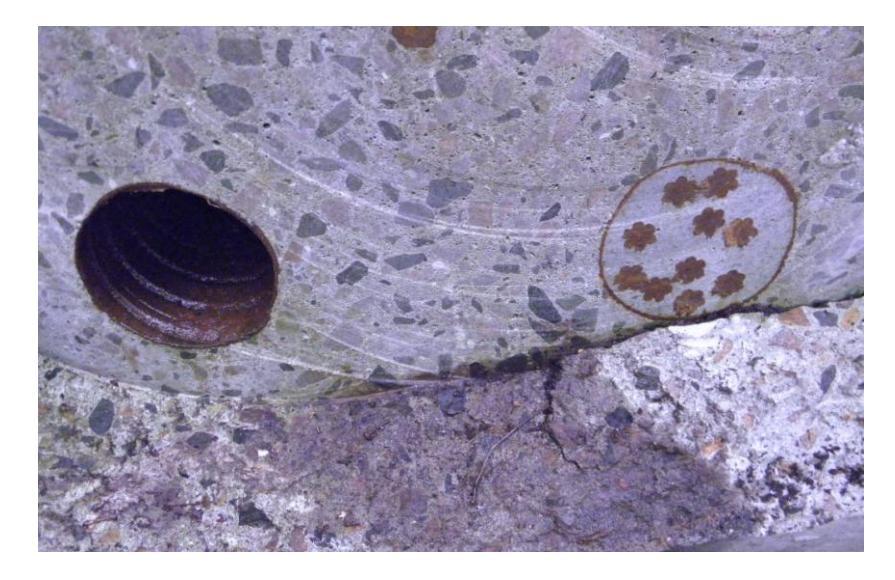
Figure 21. End cut in the slab for illustration of the empty duct and the injected duct with the 10 strands

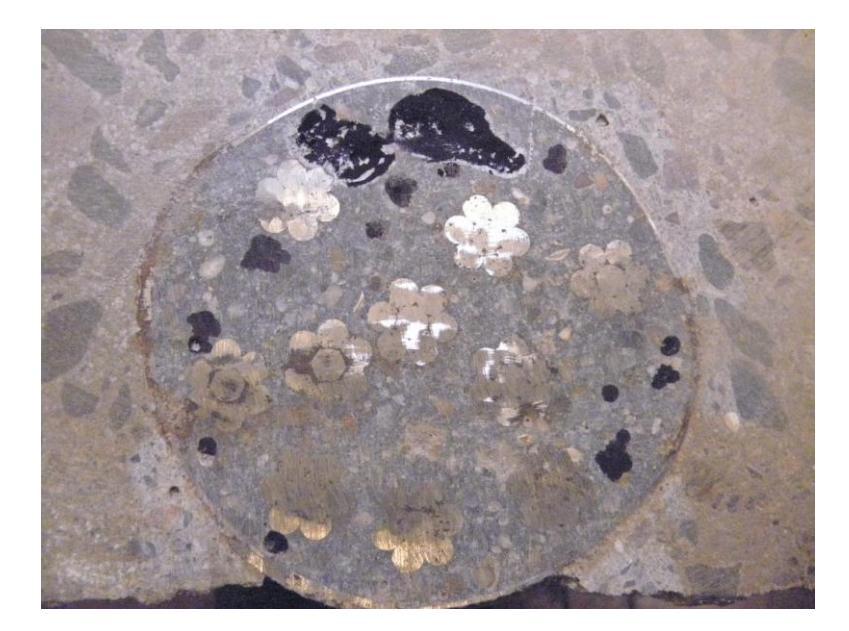
Similarly, cuts were made at the D position figure 7, and a "poorly" injected cable duct was found with smaller air inclusions colored black in the photo below. Despite the air inclusions the strands are fully protected by the grout.

Fig.22. Cut at the D position in figure 7. The air bubbles found are enhanced by black marking. The corresponding impact-echo signal is shown in fig. 20.
