Non-Destructive Testing of joints in precast element structures

Claus Germann Petersen, M.Sc., MBA, Germann Instruments A/S, Denmark
(germann-eu@germann.org)

Abstract

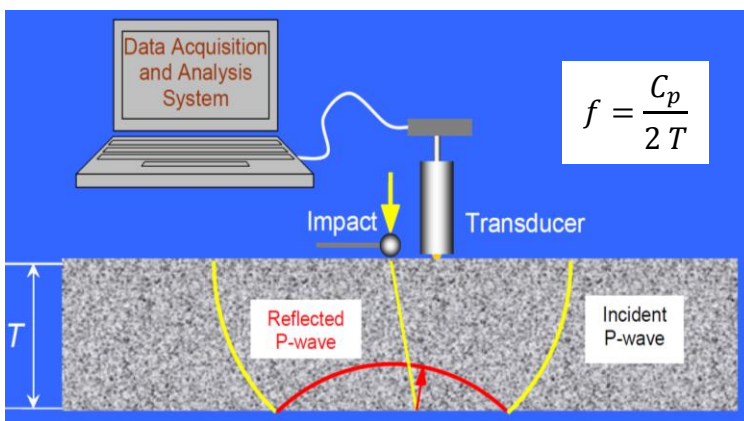
Fig. 1. Impact-Echo principle and main equation.

f = Frequency (kHz)

C_p = P-Wave speed (m/s)

T = Travel path (mm)

A short mechanical impact is produced on the concrete surface with a small steel sphere. This impact generates stress waves that propagate into the concrete. When the P-wave (the longitudinal wave) reaches a material (e.g. air, steel, soil, etc.) with a different acoustic impedance (wave speed x density), it is reflected and travels back to the surface where the impact was generated. The reflective surface is normally the back side of the concrete member but if this concrete has embedded objects or defects such as voids, honeycombs, cracks, etc., they also act as reflective surfaces. A sensitive displacement transducer next to the impact point picks up the displacement of the surface due to the arrival of the P-wave. The P-wave is then reflected back into the member and the cycle begins again. Thus the P-wave undergoes multiple reflections between the two surfaces and the recorded waveform of surface displacement has a periodic pattern that is related to the depth of the reflective surface for a given wave speed. This displacement waveform is transformed into a frequency domain to produce an amplitude spectrum that shows the predominant frequencies in the waveform. The analysis of these frequencies is the basis of the Impact-Echo method which is governed by the equation shown in Figure 1. The DOcter instrument is illustrated in operation in Figure 2. Each measurement takes only 1 second.

In order to obtain the P-wave wave speed (C_p) of the mortar, the instrument was calibrated in an area of the wall with known good quality filling (see Figure 6) and the wave speed was estimated to be 3,800 m/s (a reasonable P-wave speed for the mortar) from the equation shown in Figure 1:

$$f = \frac{C_p}{2T} \quad C_p = 2Tf = 2(200)(9.5) = 3,800 \text{ m/s} \quad \text{with } f = 9.5 \text{ kHz, measured by DOCTer (see Fig. 7)}$$

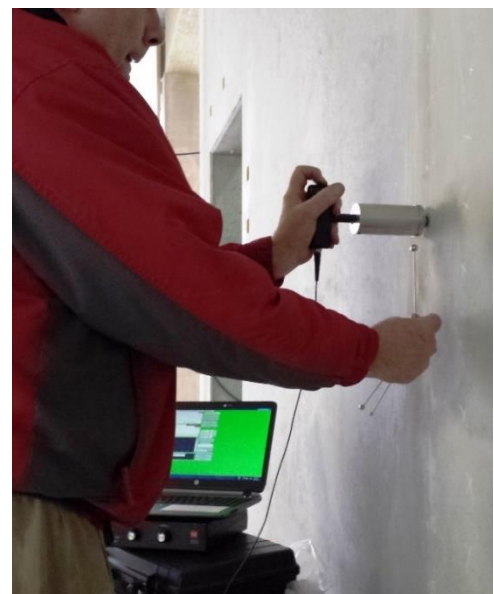
Fig. 2. DOcter Impact-Echo in progress.

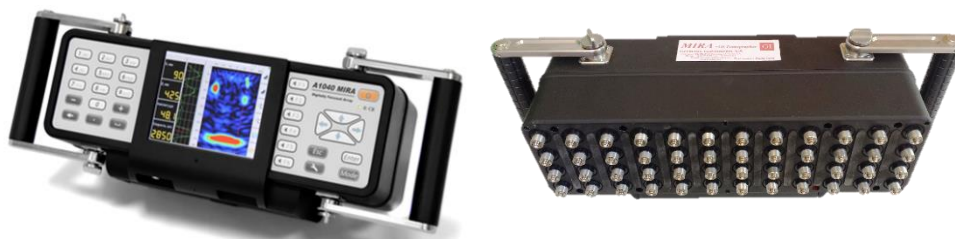
Fig. 3. The MIRA ultrasonic-echo tomographer. Front face at the left with the display showing a cross section scan. To the right, the 4 x 12 transducer array antenna.

The data captured can later be transferred to a computer with a dedicated software to create a 3D image that allows views of different slices of the reconstructed internal structure to identify the locations of the reflecting interfaces, which can be the opposite side of the concrete member (back wall reflection), reinforcing bars or concrete-air interfaces such as voids, delaminations, honeycombs or other defects alike. Figures 3 and 4 show the instrument.

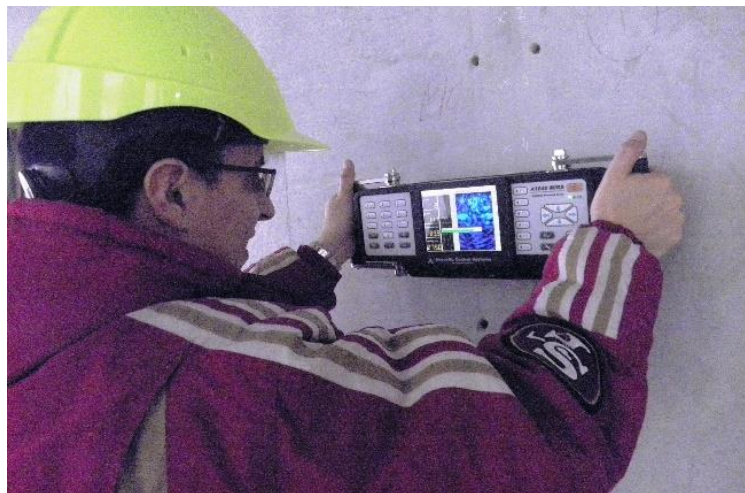
Fig. 4. The MIRA ultrasonic-echo tomographer testing in progress.

Figure 12 shows examples of B-scans from 3 different points corresponding, from left to right, to filled-out joint, joint with small defects and joint with big defects. Since the MIRA was placed transversally to the longitudinal direction of the vertical joint as shown in Figure 4, the plane of a B-scan corresponds to the transversal cross section of the joint.

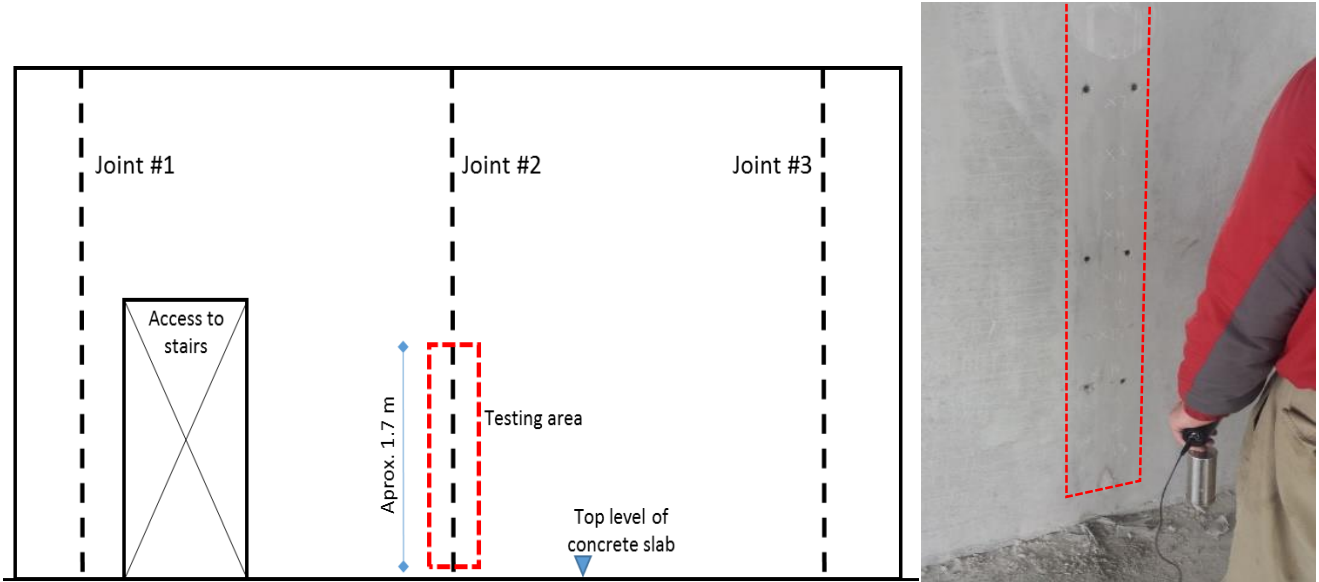
Fig. 5. Lateral view of the wall and testing area

A vertical column of 17 testing points, with 100 mm spacing in between, were selected for the joint in the ground floor and 18 points, same spacing, for the joint in the first floor. Tested concrete walls were 200 mm thick (see Fig. 5).

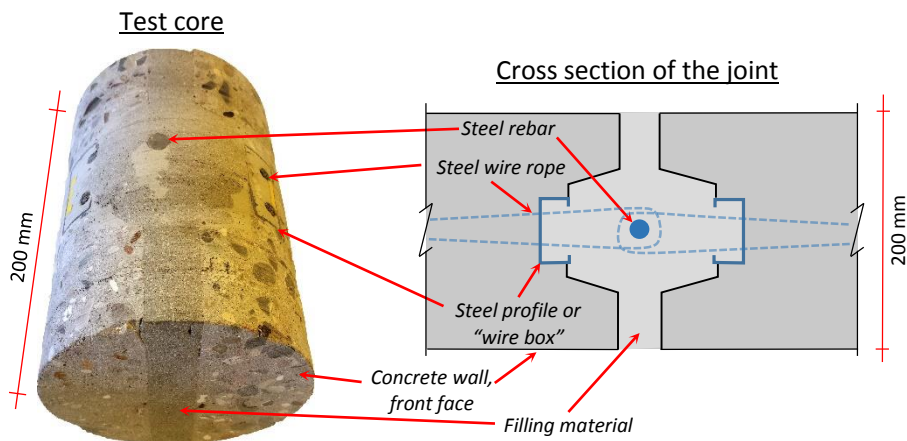
Fig. 6. A solid concrete core extracted from the joint for verification together with a drawing of the joint's cross section.

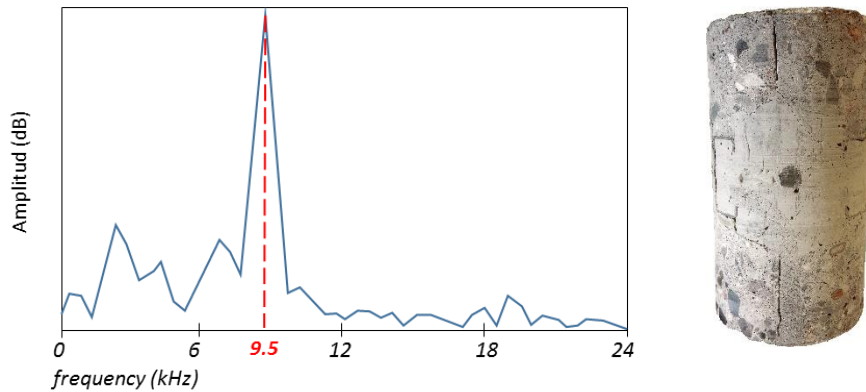
Fig. 7. Recorded spectrum of a filled-out joint section. One single main peak is displayed, 9.5 kHz in this case (red line), corresponding to a thickness of 200 mm for a P-wave speed of 3,800 m/s. A 150 mm diameter core was taken from the section for verification, shown adjacent.

Figure 7 shows the frequency spectrum of the verification test in joint 2FL which was the reference for comparing the rest of the testing points. It can be seen that the main peak is indicating the 9.5 kHz value used for the calculation of the wave speed velocity and that there are no other major peaks indicating other reflective surfaces than the one from the back side of the wall.

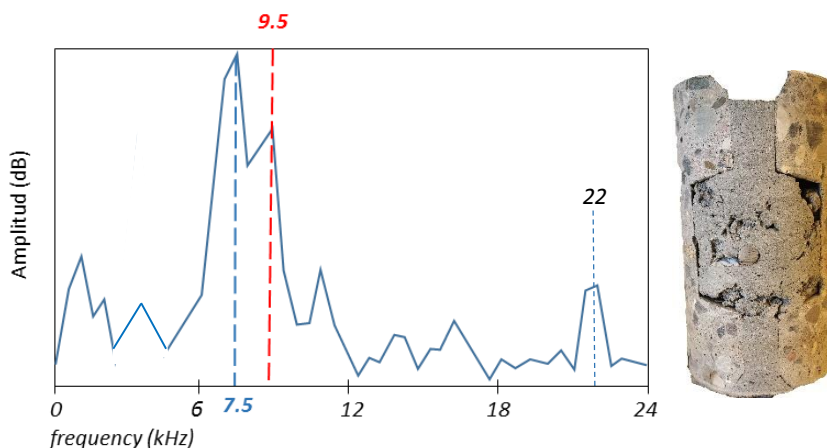
Fig. 8. The frequency of the main peak has dropped to 7.5 kHz (blue line). The red line shows the position at 9.5 kHz where the main peak should have been according to Fig. 7. The amplitude in this point is still high, meaning that part of the P-wave still runs through solid material. Notice also the 22 kHz frequency peak coming up, related to a larger possible defect. A 150 mm core was taken from the section for verification shown adjacent.

Figure 8 shows this case with data obtained from joint 2FL. A mixed frequency shows up, partly the solid frequency at 9.5 kHz and partly a frequency at 7.5 kHz related to a longer travel path than the 200 mm thickness of the wall. The interpretation is a partly injected joint with small voids, which was confirmed by the core drilled out shown adjacent to the spectrum. A smaller frequency peak at 22 kHz is also showing up at the right side of the spectrum, however it is not big enough to identify it clearly in this case.

It can be also noticed that there are some other peaks on the left side of the spectrum (low frequency region), most certainly caused by e.g. the Raleigh Wave or flexural displacement. They are not important keeping a focus only on the main peaks of the solid frequency during the analysis, a drop in this frequency and higher frequency peaks coming up.

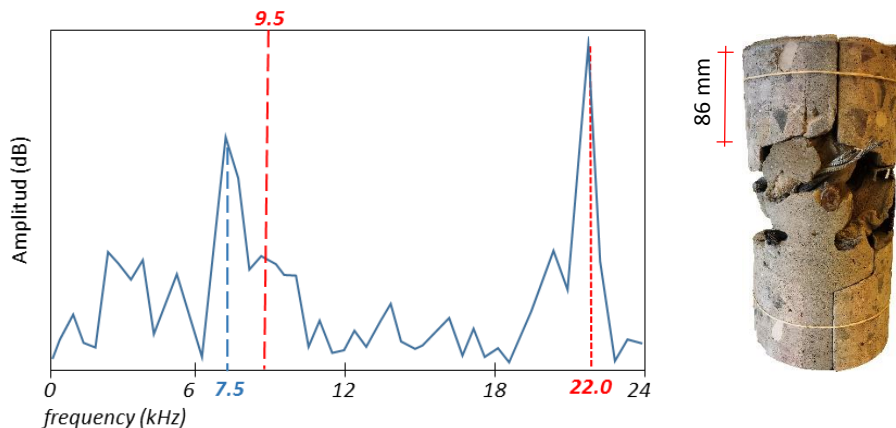
Fig. 9. The blue dotted line at 7.5 kHz indicate a longer travel path than the 200 mm related to a frequency of 9.5 kHz. The P-wave runs around a defect. A second main peak in the spectrum shows reflection from a large defect at 22 kHz related to the depth of the defect. A 150 mm core was taken from the section for verification and it can be seen that the depth of the defect was predicted accurately.

This time the drop of the main peak of the spectrum is followed by a large second main peak in the higher frequency region, meaning that the defect is big enough to clearly transmit a reflection by itself for the impactor selected. Using this high frequency with the same equation, the depth of the defect can be calculated as follows:

$$T = \frac{C_p}{2f} = \frac{3,800}{2(22)} = 86 \text{ mm}$$

Figure 9 shows this case with data obtained from joint 2FL.

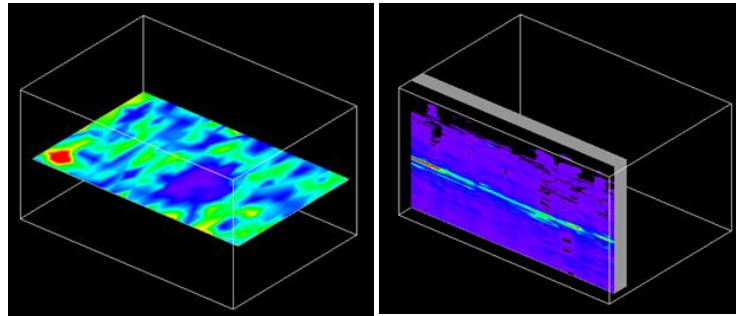
Fig. 10. Screenshots of impact-echo representations made by the MIRA d'Or software. On the left, a cross section parallel to the surface at 150 mm depth in a slab. The purple area shows a honeycombing and the red one shows a void. On the right, a cross section perpendicular to the surface showing the backwall represented by the bright green line.

A dedicated software has been developed recently to facilitate the interpretation. The application creates 2D and 3D visual representations of the results obtained from a grid of closely-spaced test points. The technique consist on using the amplitude spectrum to construct a volume model of the test region from which locations of reflecting interfaces can be presented as images where a color coding is used to

represent the amplitude of each frequency. See Fig. 10. This software was however not used in this case as only 1 line of testing points was implemented.

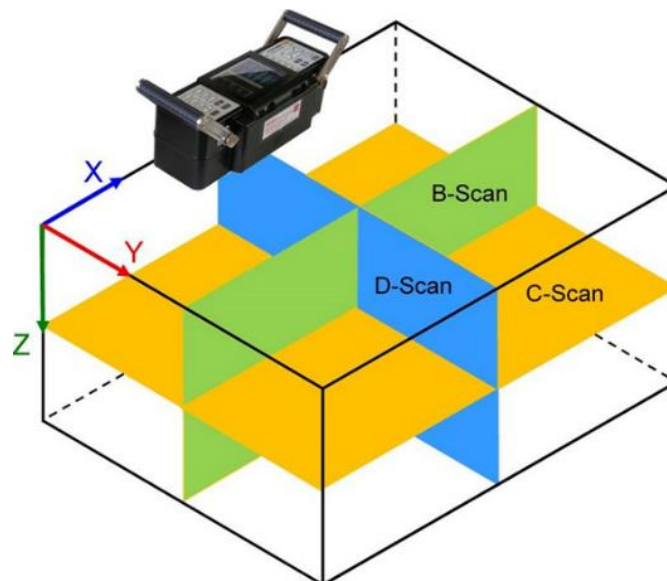
Fig.11. Identification of the 3 orthogonal planes of MIRA according to its position on the surface.

Regarding the use of the MIRA ultrasonic-echo tomographer, one measurement was done at each point that had been previously tested with the Impact-Echo method. However, with MIRA, the coverage of each measurement is about 250 mm width and the image of the plane below the instrument is displayed in 3-4 seconds (the so-called “B-scans”, see Figure 11).
