Repair monitoring using Impulse - Response method

The tests were carried out by **GEOTEST SA** at a warehouse for foods and drinks. The warehouse covers an area of about 36.000m² and was build in 2005.

The warehouse's concrete floor suffers from extensive cracking on its surface.

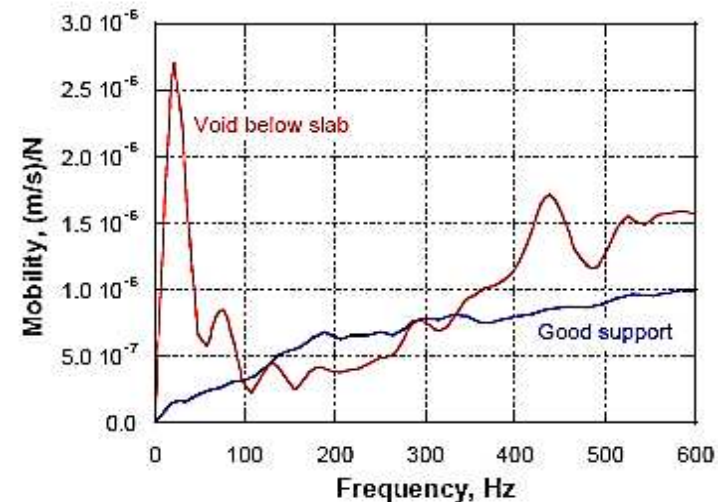
Impulse – Response Method

The function of the force in time, that is produced by the hammer and the measured velocity response is transformed in the frequency domain using the Fast Fourier Transformation (FFT).

The range of velocity response divided by the range of force and the "mobility" is shown as a function of frequency. The mobility is given in units of speed per power (m / s) / N.

The parameters of the mobility diagram (Figure 1) used for assessing integrity are:

- The dynamic stiffness
- The average mobility (lined bar)
- The mobility slope between 100 and 800 Hz
- The voids index (the ratio between the width of the initial maximum mobility to the value of the average mobility)

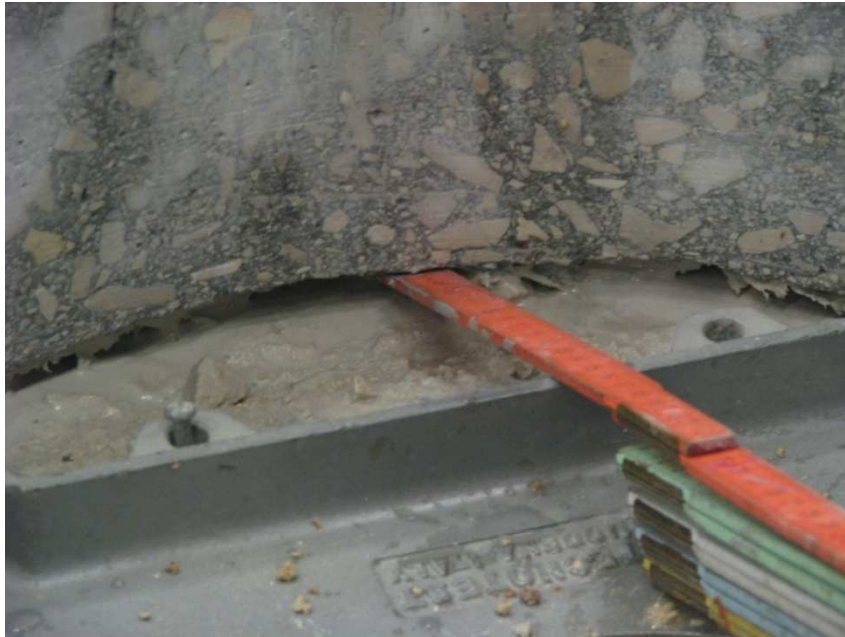
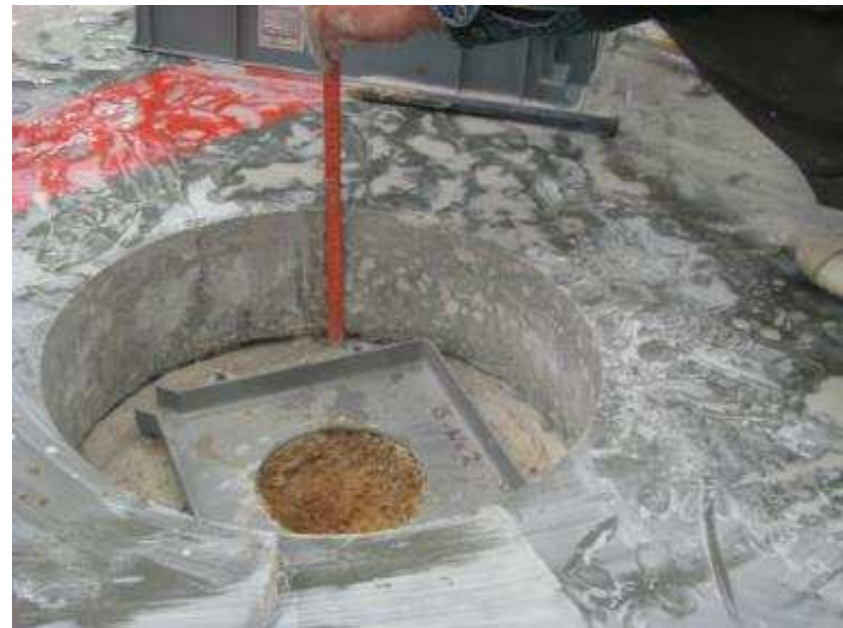
Impulse – Response Method - Cores

1st Finding:

Voids Below Slab

- Filling of the the voids between the slab and the sub-base by grout injections, while strengthening the sub-base
- Sealing of the cracks.
Some of the cracks will be sealed using epoxy products to offer structural support

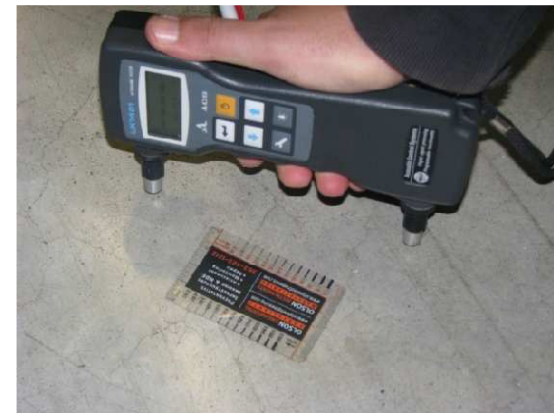
Crack Depth Measurements using Ultrasonic

- The process of calculating the crack depth is the following:
 1. Measure the ultrasonic velocity at a healthy part of the concrete,
 2. Measure the ultrasonic velocity by placing the transmitter and the receiver on both sides of the crack,
 3. Calculation of the crack through the equation:

- From the instrument calibration was showed that the measurements taken from instrument was 20% higher than the real cracks depth .

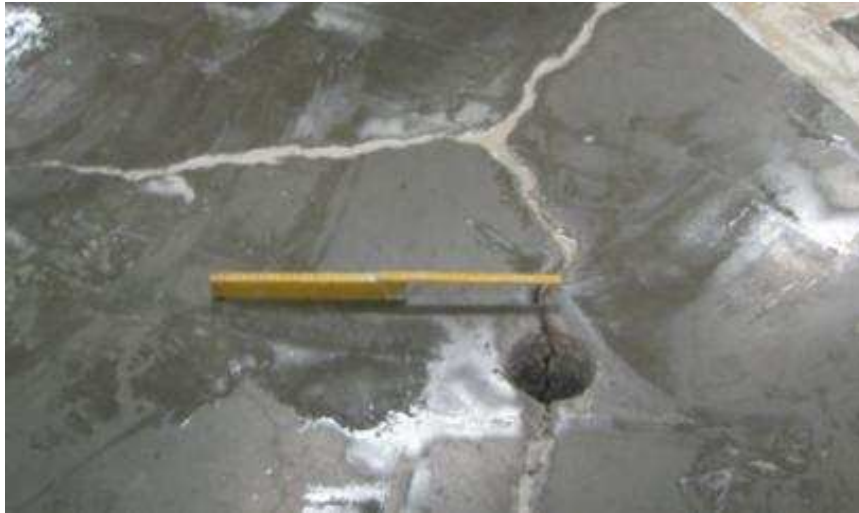
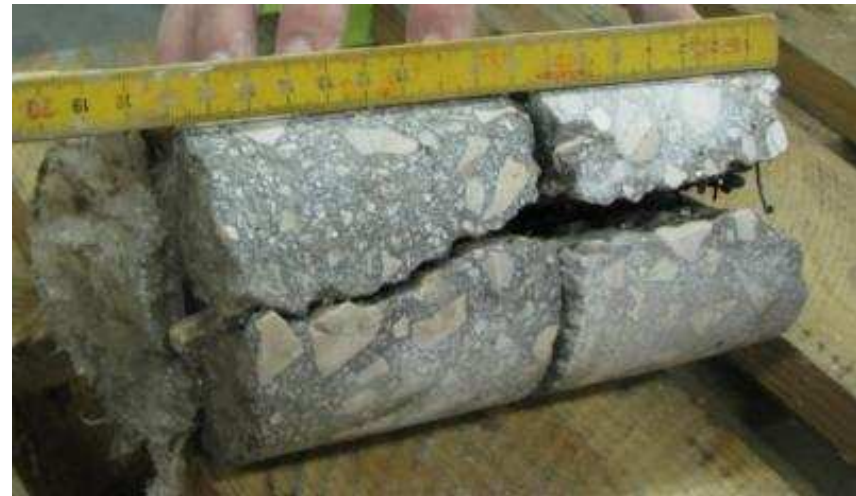
Crack Depth Measurements

3rd Finding:

Deep Cracks
and
deterioration
area in both
sides

Some of the cracks will be sealed using elastic products, in order to continue to function as extra joints

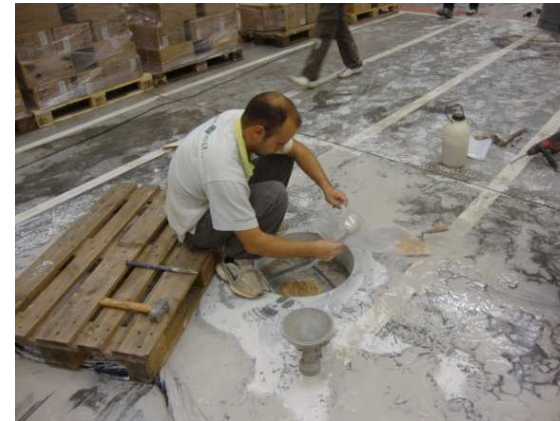
Compaction control and sub-base quality

- After 50cm diameter core cutting, it has been executed compaction test with cone and sand method, to the sub-base layer underneath the slab
- The test was carried out at two (2) sites

No	Site	Compaction (%)
1	Site 1	103.1
2	Site 2	107.9

4th Finding:

Low thickness extra sub-base layer (5cm)

Cannot have been compacted successfully during the construction and created local weak areas

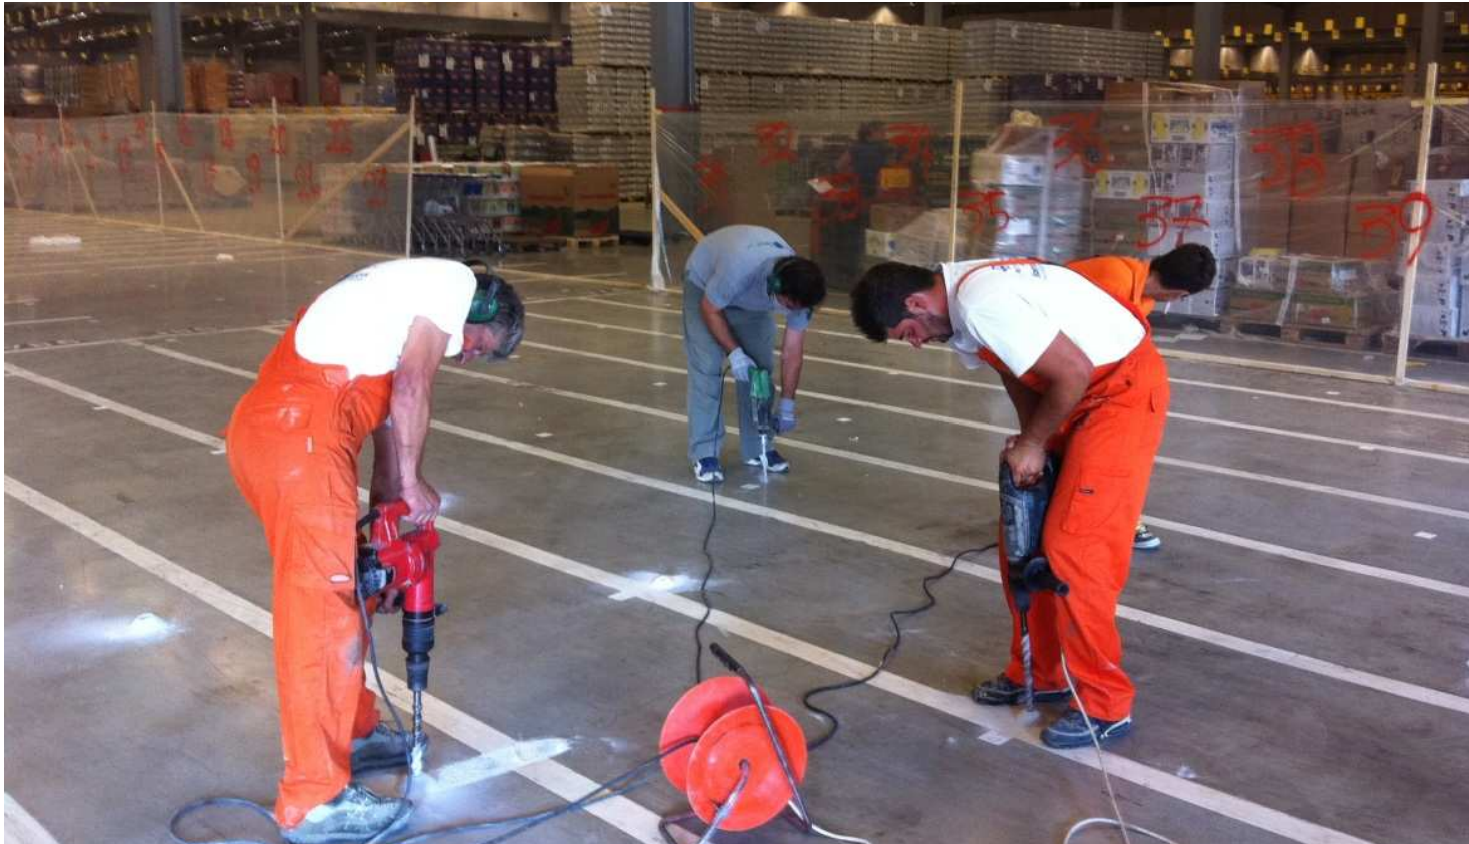
Drilling

- A triangular grid was designed, with side dimension of 1,60m
- Holes of 26mm diameter were drilled up to a depth of around 20-22cm
- Grout with a W/C ratio of 0,7 to 0,9 (under pressure of 2bars at the maximum) was injected through the drilled holes using equipment specifically designed according to the needs of the project

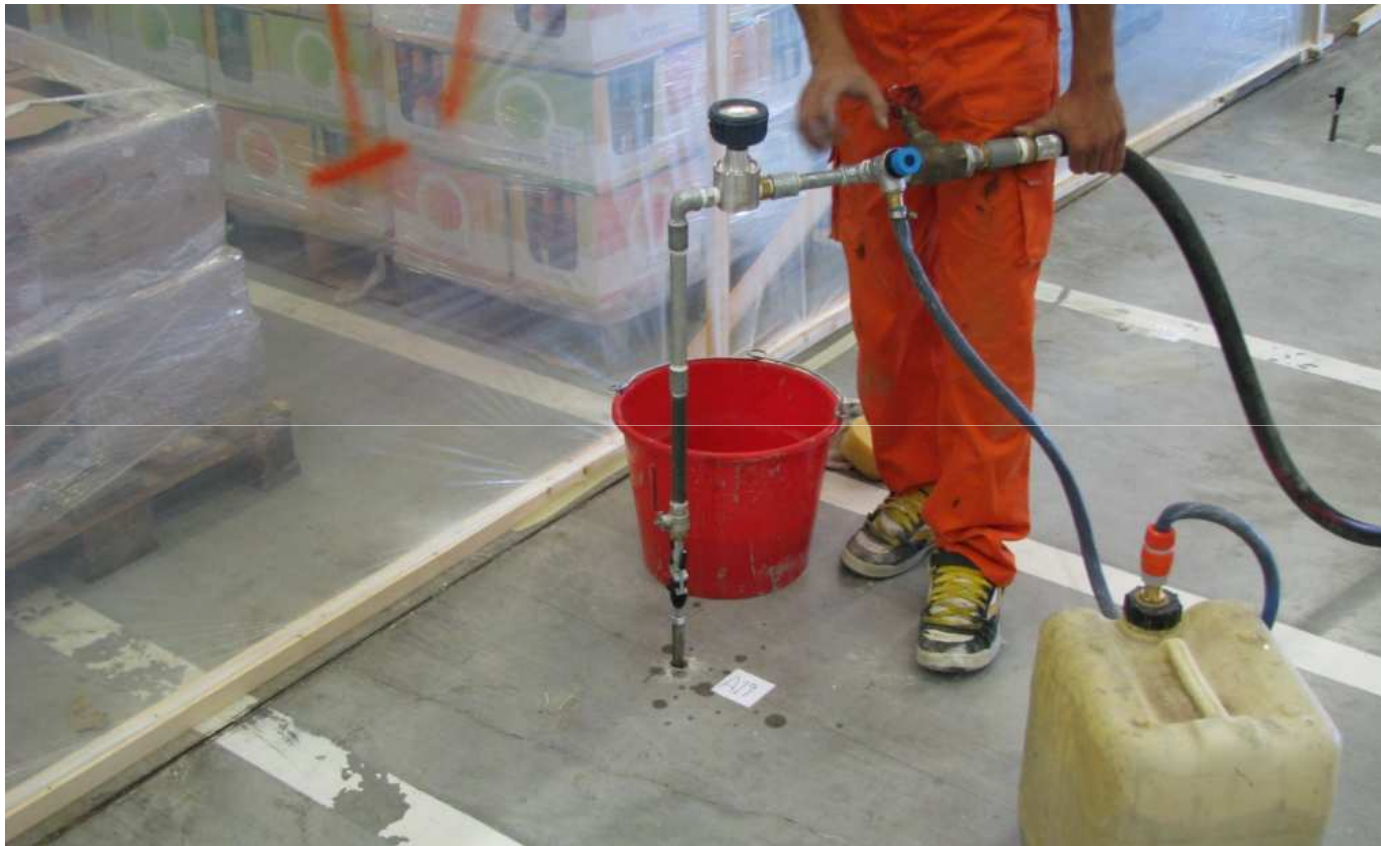
Injection

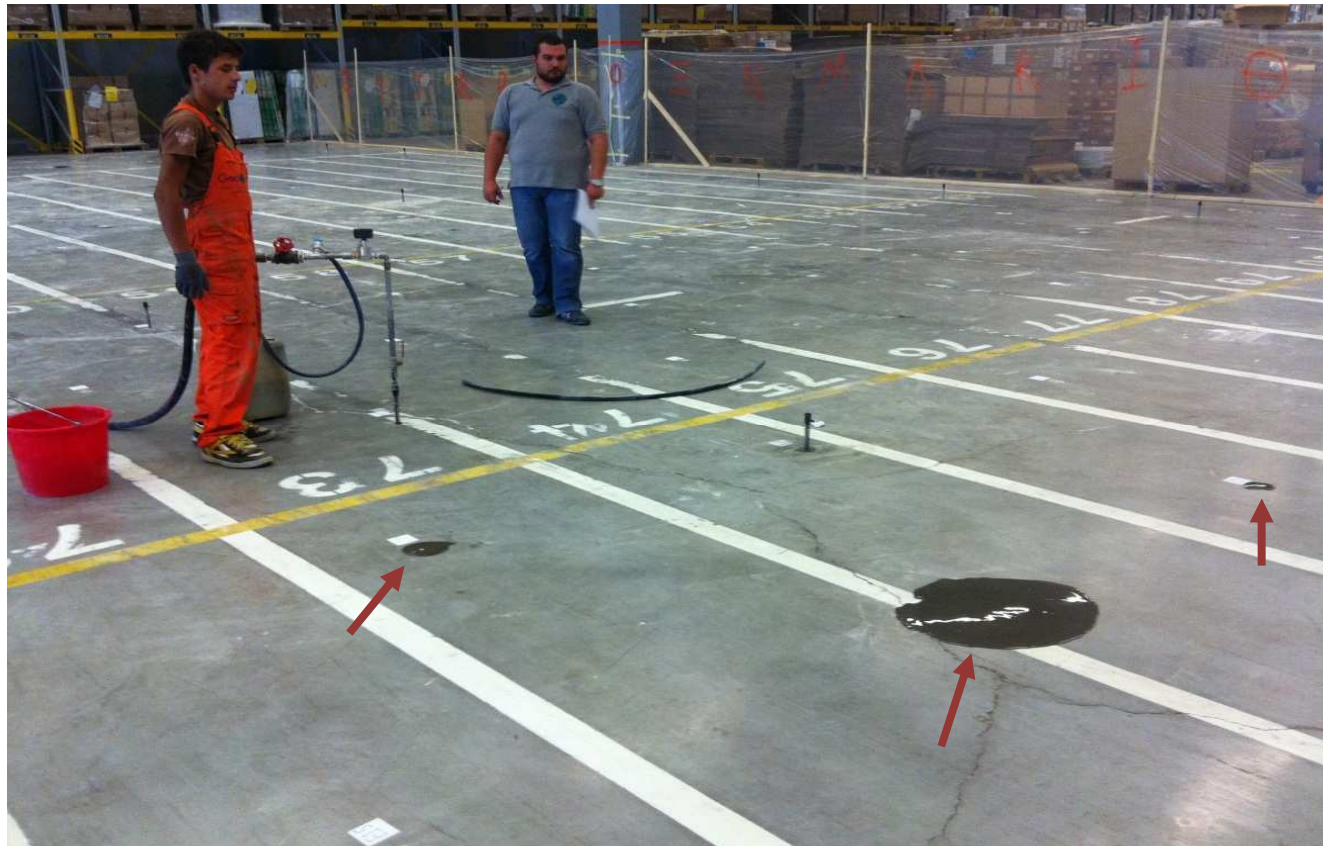
Grout pouring from adjacent holes

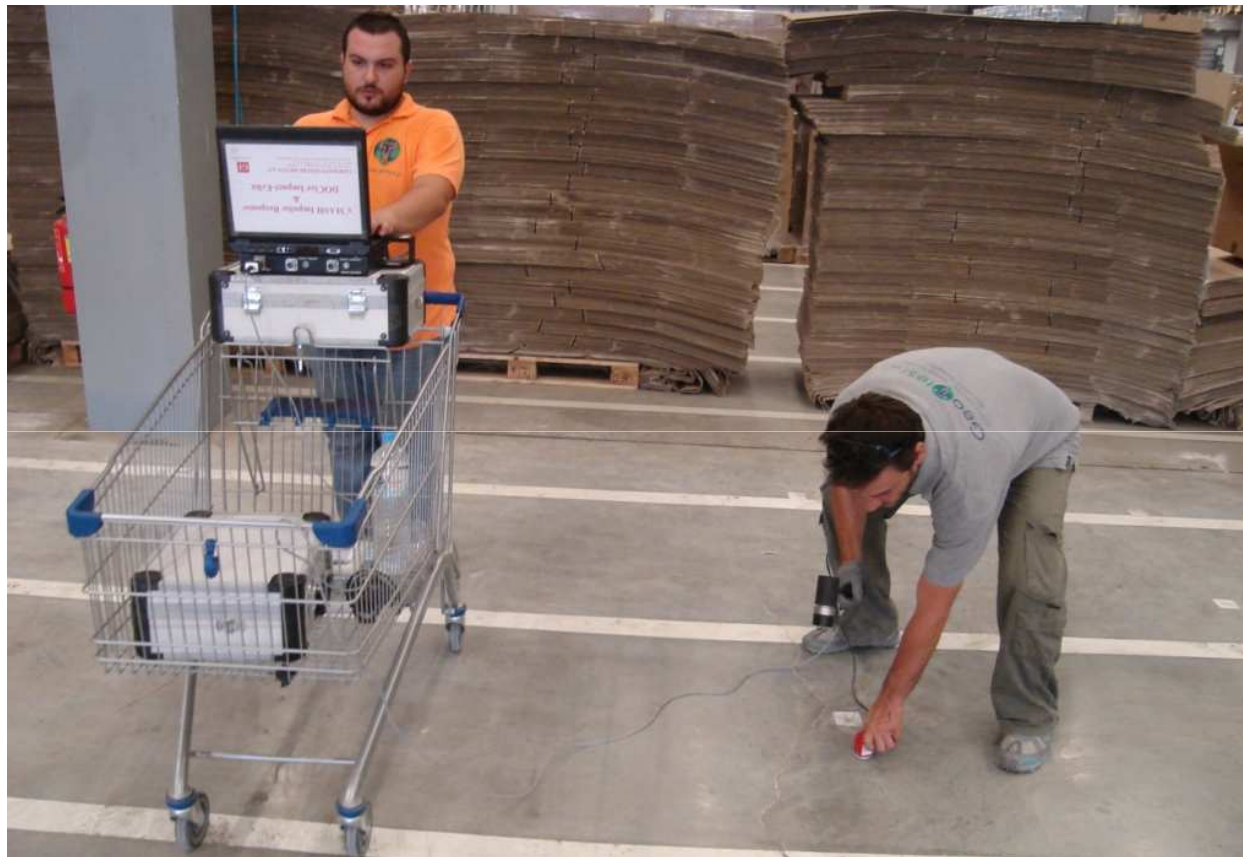
Test using the Impulse – Response method

The slab was tested using the Impulse – Response method for voids below the slab, using a 22x44 grid:

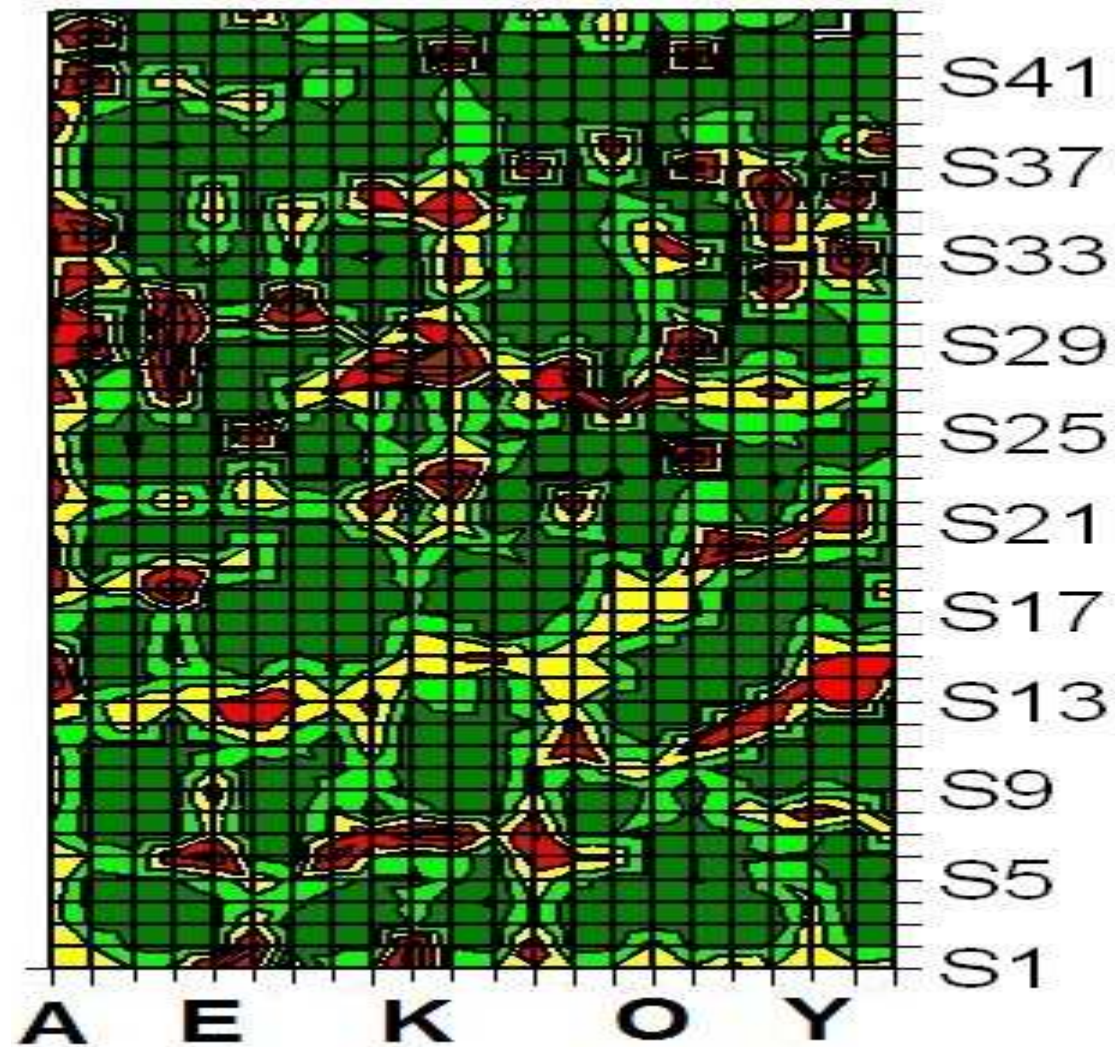
Before the Injections

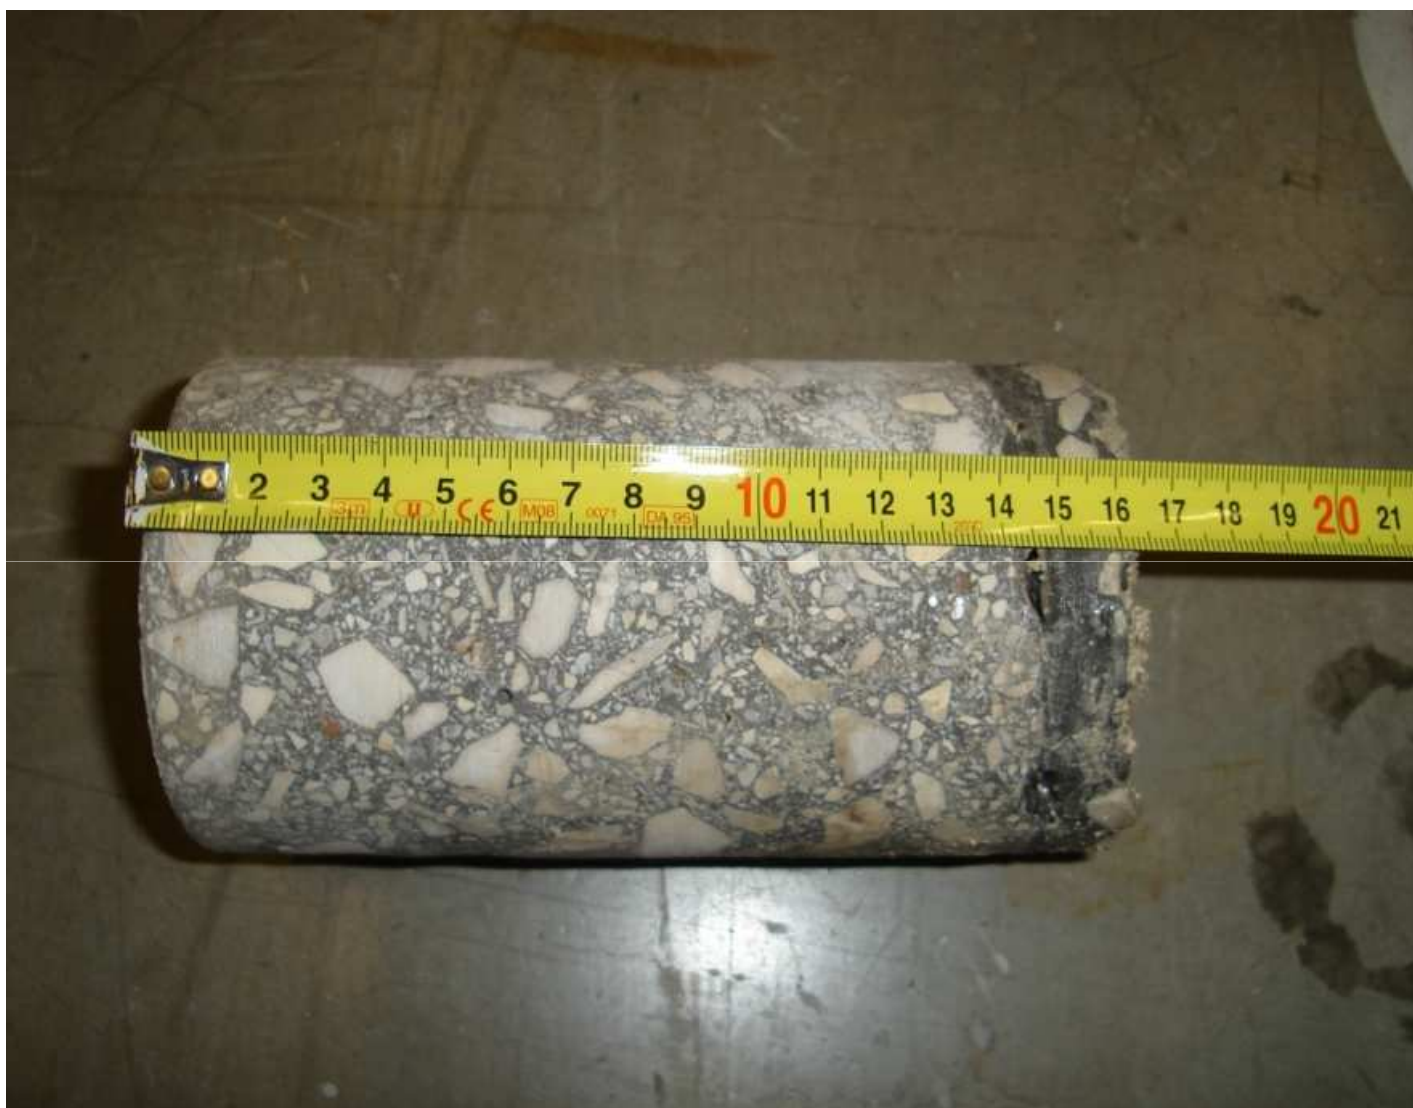
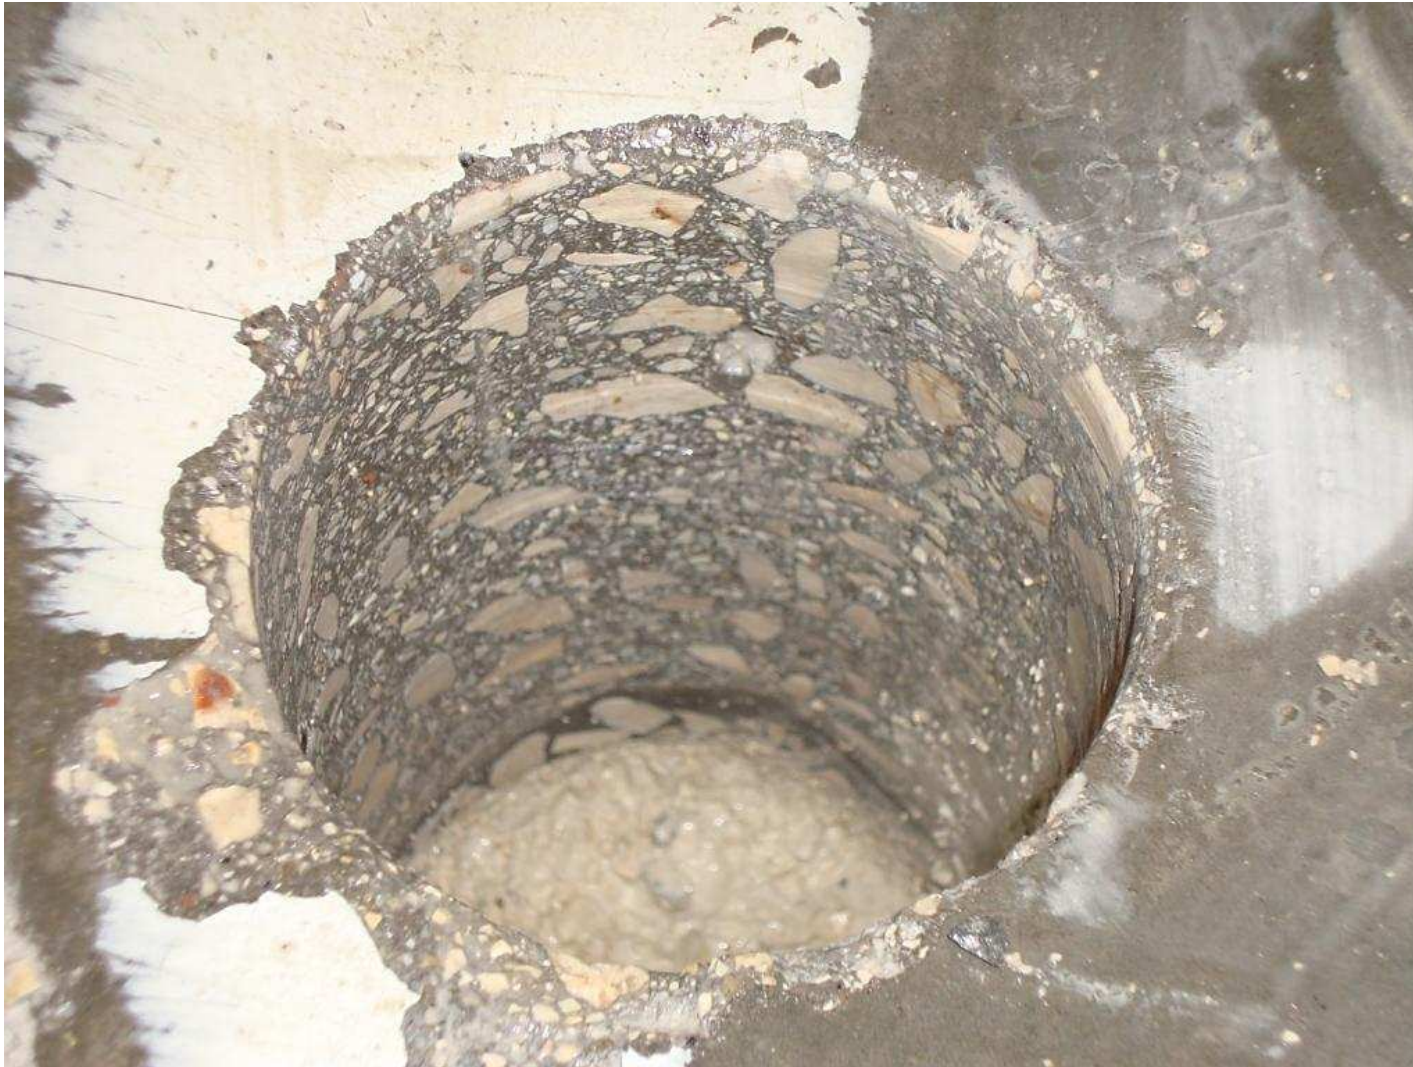
**The results of the Impulse – Response
method were confirmed by concrete
cores that were cut off**
