Injection quality of steel cable ducts evaluated by NDT

C.G. Petersen

Germann Instruments A/S, Copenhagen, Denmark

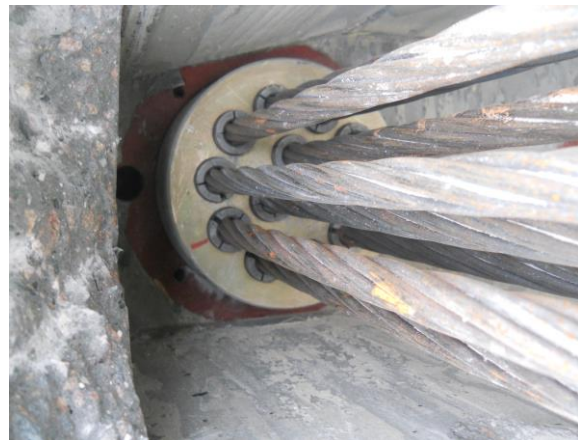
Figure 2. Post-tensioned strands

During construction of post-tensioned structures strands are inserted into steel cable ducts (Fig. 1) and tensioned (Fig. 2) after the concrete member has achieved sufficient strength. Subsequently, pressure injection of the protective grout takes place from tubes connected to the ducts until the duct has been filled completely with grout, hopefully.

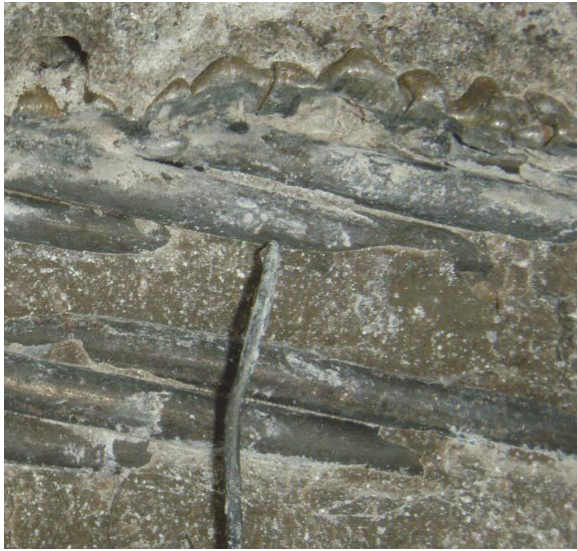
Figure 3. Sound strands in well injected duct

The injected grout has to encapsulate the strands (Fig. 3) to prevent corrosion of the strands (Fig. 4) and to ensure stress transfer from the strands to the structural concrete member. The examples in Figures

3 and 4 are from a post-tensioned bridge beam in Finland constructed in 1971 (Rapaport 2010).

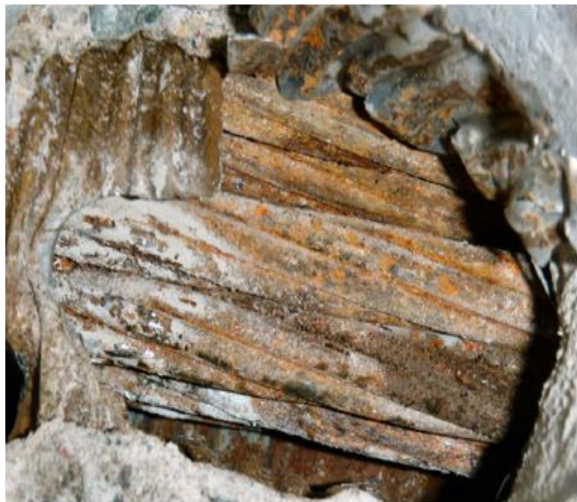
Figure 4. Corroded strands in an empty steel duct.

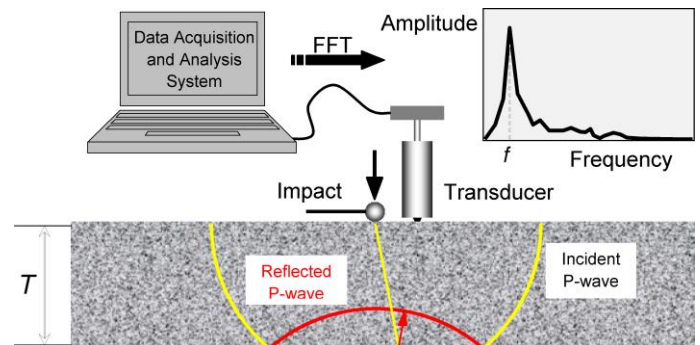
Figure 5 is a schematic of the impact-echo test. A short duration mechanical impact is produced on the concrete surface with a small steel sphere. This impact generates three stress waves, an R-wave on the surface and a P-wave and an S-wave that propagate into the concrete. When the P-wave (the longitudinal wave) and the S-wave (the shear wave) reach a boundary with a material having a different acoustic impedance (wave speed \times density), they are reflected and travel back to the surface where the impact was generated. By placing the transducer close to the impact point, the response from the P-wave is maximized, while the S-wave response is minimized. The transducer is a sensitive broadband displacement transducer.

Figure 5. Impact-echo method

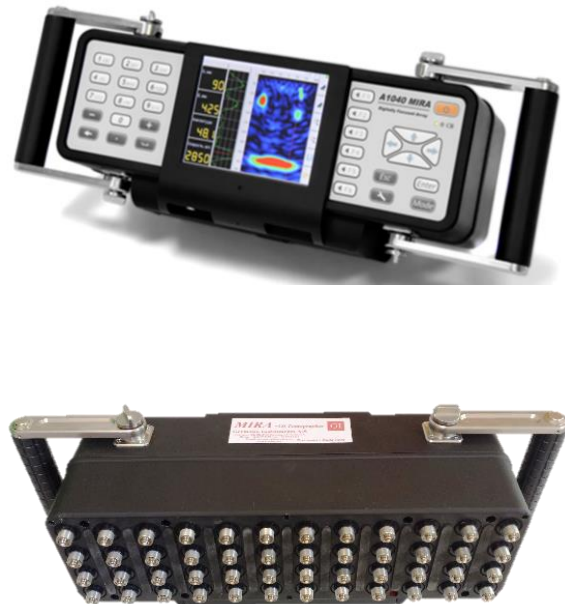
Figure 7 shows the ultrasonic-echo instrument used in this work. The 4×12 transducer array antenna produces many transit time measurements during each test that are analyzed using the synthetic aperture focusing technique (SAFT) in real time to reconstruct a 2D image of the cross section below the instrument. It takes about 3 to 4 seconds to complete data acquisition and data processing at each test location.

Figure 7. The ultrasonic-echo tomographer: (top) top face with display showing 2D cross section image; (bottom) the 4×12 transducer array antenna.

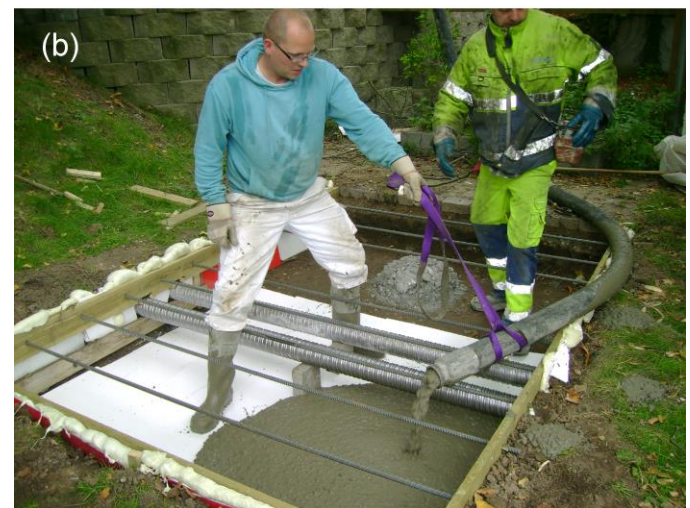
The slab was cast using self-consolidating concrete. Figure 9(a) shows the slab formwork with reinforcement and ducts in place before placing the

concrete. Figure 9(b) shows the self-consolidating concrete being pumped into the form.

Figure 9. (a) Slab formwork with ducts and bars installed; (b) placing the self-consolidating concrete.

The cable duct was kept in the same vertical position for 30 days and then placed carefully in the slab formwork (Fig. 9(a)). The upper end of the duct was positioned on the “south” side of the slab, with the strands sticking out of the slab as shown in Figure 8.

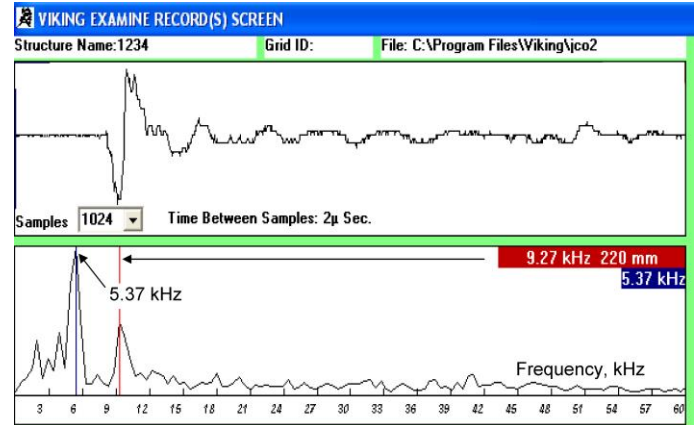
Figure 13 shows the result for a test at a point over the fully grouted duct. The 5.37 kHz frequency measured is the same as the solid frequency in Figure 11, indicating a P-wave travel path of 380 mm. This can only happen if the duct with the strands is fully grouted with no air intrusions, provided the testing is made over the duct. To make sure this is the case, there has to be an additional reflection from the strands inside the grouted duct. This reflection shows up as a peak at 9.27 kHz, equivalent to a depth to the steel strands of $T_s = 4081 \text{ m/s} / (4 \times 9.27 \text{ kHz}) = 110 \text{ mm}$ (half of the 220 mm indicated in the red box), based on the impact-echo equation for air-concrete-steel as shown in Figure 6. An 8 mm impactor was used.

Figure 13. Impact-echo result over fully grouted duct.

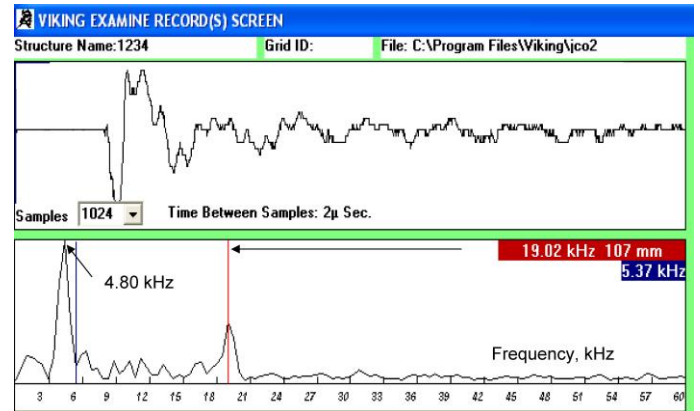
Fig. 14 shows the result for another test at a point above the grouted duct. The P-wave has a travel path of more than 380 mm as the frequency has dropped from 5.37 kHz to 4.80 kHz. This can only happen if there is air in the duct. The air interface is positioned at a depth of 107 mm as indicated by the peak at a

frequency of 19.02 kHz. The interpretation is that the duct is poorly grouted and has air voids. An 8 mm impactor was used.

Figure 14. Impact-echo result due to voids in grout

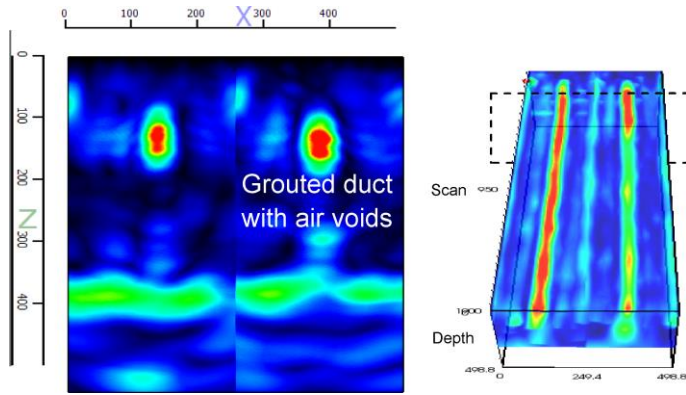
Figure 20 shows an end view of the slab and ducts at a plane 150 mm from the south face. The similarity in the red colors of the images representing the two ducts indicates that the grouted duct is in fact not fully grouted. Starting from the south face of the specimen and extending about 200 mm along the

duct, the red reflection indicates air voids are present in the duct (see also Figs. 16 and 17).

Figure 20. End view (B-scan) at cross section 150 mm from south face.

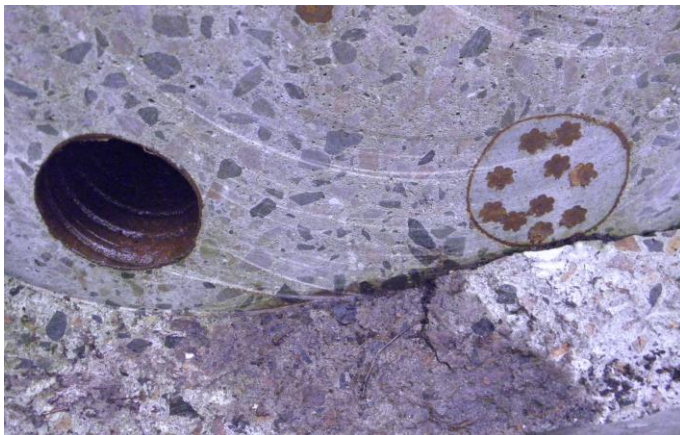
The slab was cut at two positions as shown in Figure 8 to verify the interpretations of the impact-echo and ultrasonic-echo test results. Cut 1 was made near the north face, where test results indicated the grouted duct did not have voids in the grout. Figure 21 shows that, in fact, there were no voids in the grout.

Figure 21. Cut 1 for verification that duct with the 10 strands was fully grouted.
