materials and structures matériaux et constructions

novembre-décembre 1985 n° 108

Fracture analysis of the pullout test

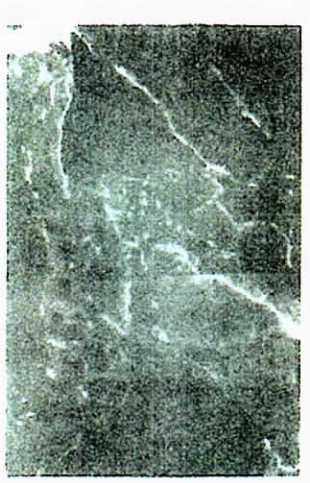
Fig. 16. — Stereo-microscope examination of crack in concrete, specimen No. 4 (see Fig. 12) in scale 1:1 (this area was 0.7 × 0.5 mm)

gives sharp reproduction for a total enlargement of up to about 10 times, with clear detection of cracks with widths down to 0.01 to 0.05 mm (Fig. 8 through 15). In selected areas, a stereo-microscope with a magnification of 20 was used. With this, any crack down to crack widths of 1 to 5 μm can be observed (Fig. 16 and 17).
