Onsite measurements of concrete structures using Impact-echo and Impulse Response

ABSTRACT: Concrete structures deteriorate, often unnoticed, in worst case the damages are not visible until it is too late for a repair or the repair will be extensive and costly. New structures may have defects from the execution compromising durability and safety. The use of NDT (Non Destructive Testing) can provide valuable information of the condition of a concrete structure and can be a valuable help when planning the maintenance of a structure. NDT can further be used during the construction phase for quality assurance of a structure. Hidden faults can be detected early and can be remedied while access to the structure is still possible without major inconvenience. Special inspections combining a visual survey with NDT techniques can disclose problems at an early state and provides valuable information of the actual condition of the structure. The use of NDT should not be used to evaluate a structure without a thorough calibration of the equipment onsite e.g. by drilling out a limited number of cores.

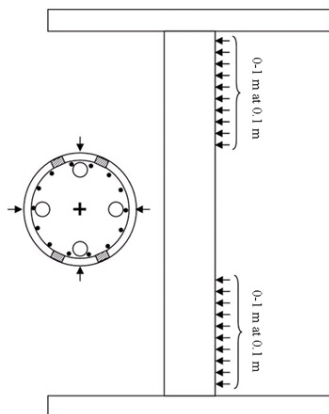
Figure 9. Elevated and sectional view of a column and the location of IE test points are marked with arrows.

Three sizes of columns were investigated. The diameters were 450 mm, 560 mm and 650 mm. Each column had 4 embedded cable ducts from level -2 (deepest basement) to level 4. From level 4 and up to level 8, only 2 cable ducts were embedded in the columns. Adjacent to two of the ducts – perpendicular to each other – plastic tubes were embedded for electrical wiring. The top and bottom of these plastic tubes were visible and were used as guidelines to locate the ducts. See Figure 9.

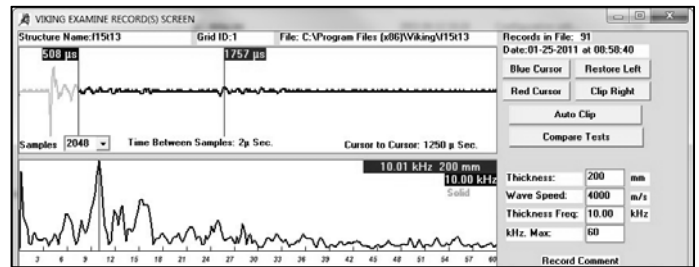
Figure 15. IE - solid signal with measured thickness of 200 mm.

IE measurements on a solid concrete gives a very distinct signal. All the cracks caused by ASR gives a lot of small reflections and thus some "noise" in the IE signal. Using Impact-Echo from the underside of the bridge deck can thus give an indication of how far down the damages from of ASR has reached. Typical signals are shown in Figure 15 and Figure 16.

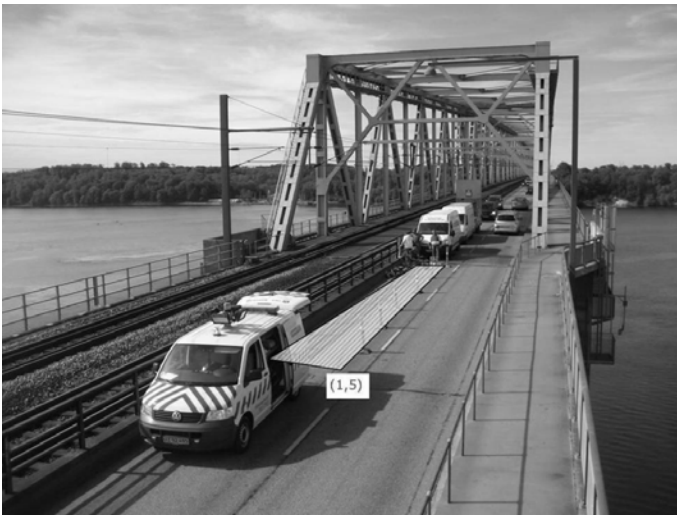
Figure 18. Photo of The old Lillebælt Bridge with one test area in between the cars.

Five test areas were selected on the bridge. These areas were tested with IR in a grid with a distance of 1 m along the bridge (up to 20 m long) and 0.5 m across (up to 2 m across). See an example in Figure 18.

The test showed that the 10 cm thick pavement was intact in all the test areas. The problem was either poor adhesion of the membrane and concrete or cracks in the concrete below the membrane (ASR). With the IR it was possible to distinct between shallow defects or deeper defects.
