Onsite measurements of concrete structures using Impact-echo and Impulse Response

Inspection Specialist, Ramboll Denmark A/S, Copenhagen, Denmark

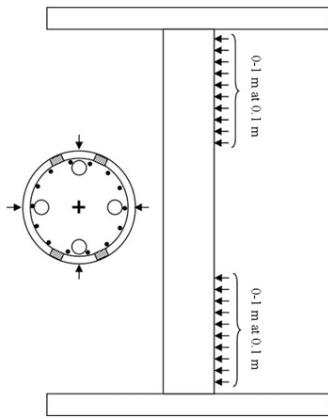
Three sizes of columns were investigated. The diameters were 450 mm, 560 mm and 650 mm. Each column had 4 embedded cable ducts from level -2 (deepest basement) to level 4. From level 4 and up to level 8, only 2 cable ducts were embedded in the columns. Adjacent to two of the ducts – perpendicular to each other – plastic tubes were embedded for electrical wiring. The top and bottom of these plastic tubes were visible and were used as guidelines to locate the ducts. See Figure 9.

Figure 9. Elevated and sectional view of a column and the location of IE test points are marked with arrows.

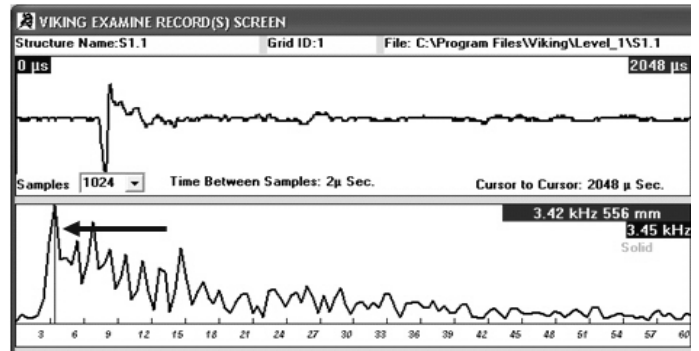
Initial testing was performed on selected columns on two floors. For verification of the impact-echo data, 50 cores were drilled into the ducts. 39 of the cores were in accordance with the data interpretation. 8 cores showed an empty duct and the interpretation of the impact-echo data was “empty or possible loose aggregates”. These 8 test results were also accepted. The last 3 cores showed an empty duct and the impact-echo data had evaluated the data as “solid”. Some typical IE results are shown in Figure 11 and Figure 12.

Figure 11. Frequency peak (arrow), which corresponds to the thickness of the column.

The investigations showed that almost 10 % of the ducts at the bottom of the columns and 33 % at the top of the columns were empty. 4 % of the tests were classified as “uncertain” and could be both loose gravel/aggregates or an empty duct.

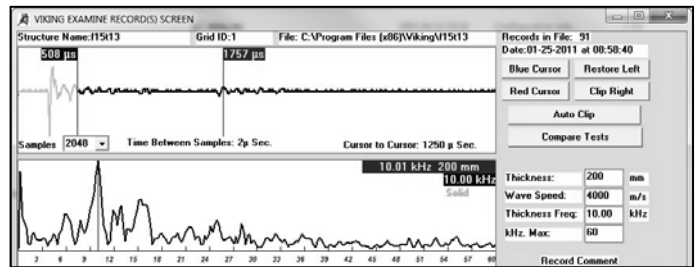
IE measurements on a solid concrete gives a very distinct signal. All the cracks caused by ASR gives a lot of small reflections and thus some "noise" in the IE signal. Using Impact-Echo from the underside of the bridge deck can thus give an indication of how far down the damages from of ASR has reached. Typical signals are shown in Figure 15 and Figure 16.

Figure 15. IE - solid signal with measured thickness of 200 mm.

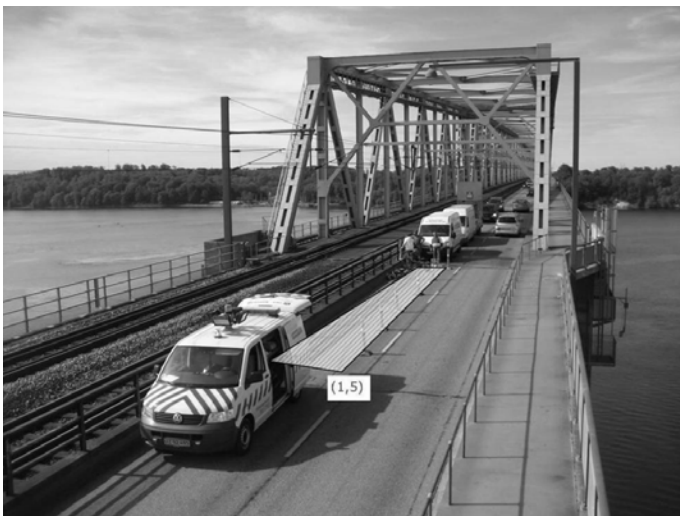
Figure 18. Photo of The old Lillebælt Bridge with one test area in between the cars.

The test showed that the 10 cm thick pavement was intact in all the test areas. The problem was either poor adhesion of the membrane and concrete or cracks in the concrete below the membrane (ASR). With the IR it was possible to distinct between shallow defects or deeper defects.

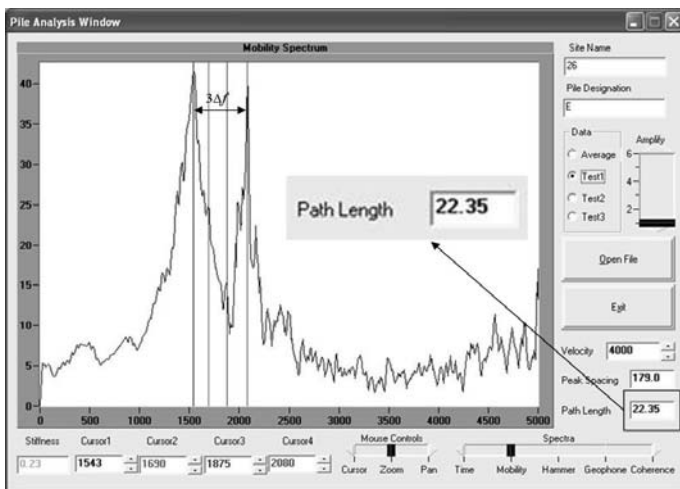
Figure 21. Mobility diagram from testing an 11 m long pile.

At the bottom of the figure the total length that the waves travel down to the end of the pile and back again is indicated as the "Path length". Figure 21 shows in this case a "Path Length" of 22.35 m, which means that the measured length of the pile is approx. 11.17 m. The true length of this pile is 11 m. The pile length is determined by equation (3):
