PRO'S AND CON'S OF HALF-CELL POTENTIALS AND CORROSION RATE MEASUREMENTS

Structural Faults + Repairs, International Conference, London, U.K., July 1st-July 3rd, 2003

KEYWORDS: Half cell potential (HCP), Corrosion rate (I_{corr}), Galvanostatic Pulse Measurements (GPM), concrete structures

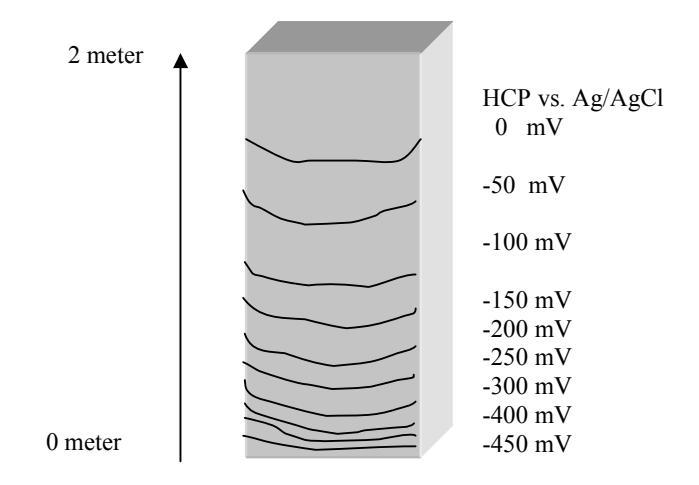
Fig.1. Typical potential map of a high way concrete pillar exposed to de-icing salts

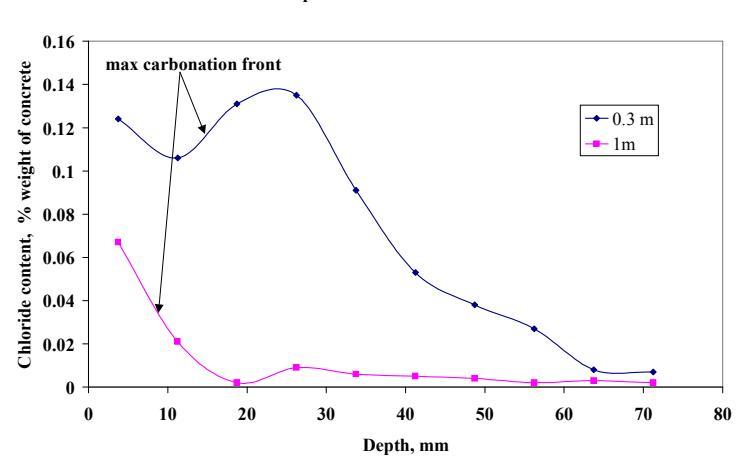
Chloride profiles in 1999 at level 0.3 m and 1 m

Fig 2. Chloride profiles at level 0.3m and level 1 m

Initial inspections, core investigations and chloride profiling in 1999 (fig. 2) pointed out column No.S303 to be suitable for corrosion rate measurements. Electrical continuity in the reinforcement was checked and a permanent connection was welded to the reinforcement.

The vertical reinforcement (Ø35 mm) is typically in 60 mm depth and the horizontal (Ø14 mm) in 40 mm depth. Already in 1999 the chloride content in level 0.3 m is so high that active corrosion can be expected. In September 2000 and in April 2001 corrosion rates were determined together with the half-cell potentials and resistance measurements [5] (fig 3).

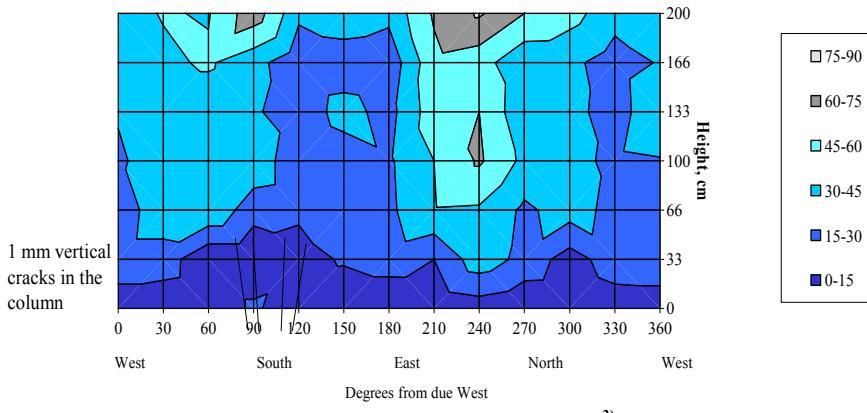
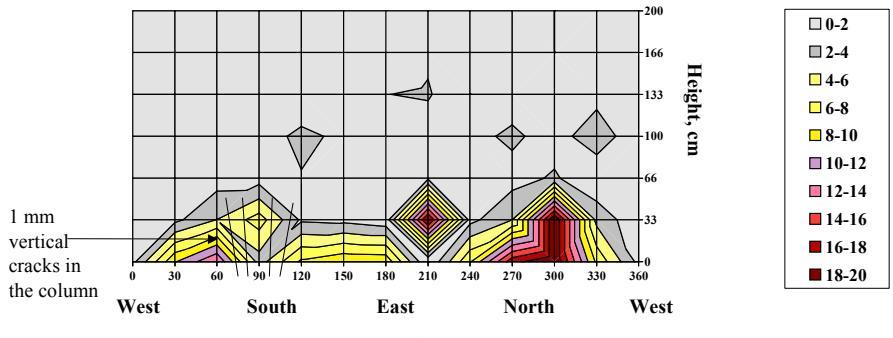
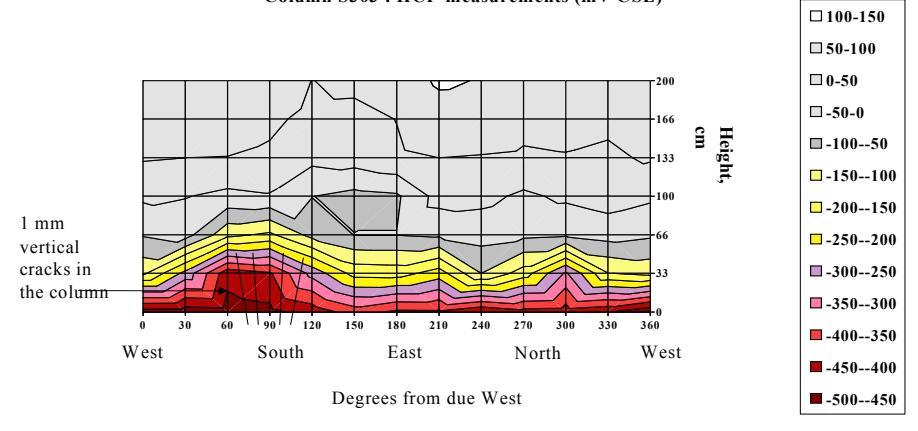
Column S303 : Resistance (kOhm)

Column S303 : Corrosion rate ($\mu A/cm^{2)}$

Fig. 3 Resistance, half-cell potentials and corrosion rates in September 2000

In this case there is a rather good correlation between resistance, half-cell potential and corrosion rate mapping. To verify the corrosion state a break-up was made at the position 90 degrees south near ground level, see fig. 4.

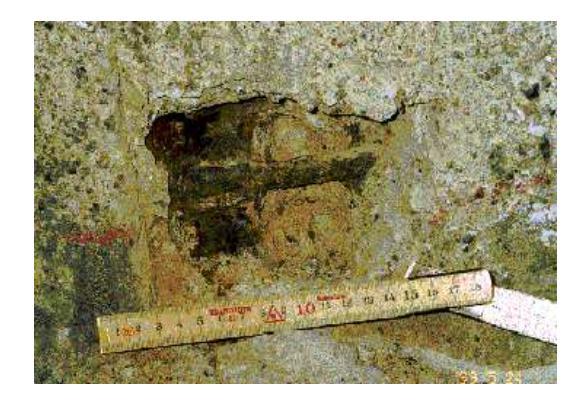
Fig. 4 Corroding reinforcement. Cross section loss : 1-2 mm

As the constructions have been examined close during the last 20 years it is possible to make a good estimate of the initiation of corrosion. Calculation of the average corrosion rate from the cross section loss of app. 2 mm and assuming the corrosion was initiated after app. 10 years gives an average corrosion rate of 9μ A/cm², which is with in the range of corrosion rates determined at this position by the GPM. The very low half-cell potentials agree with the high corrosion activity.

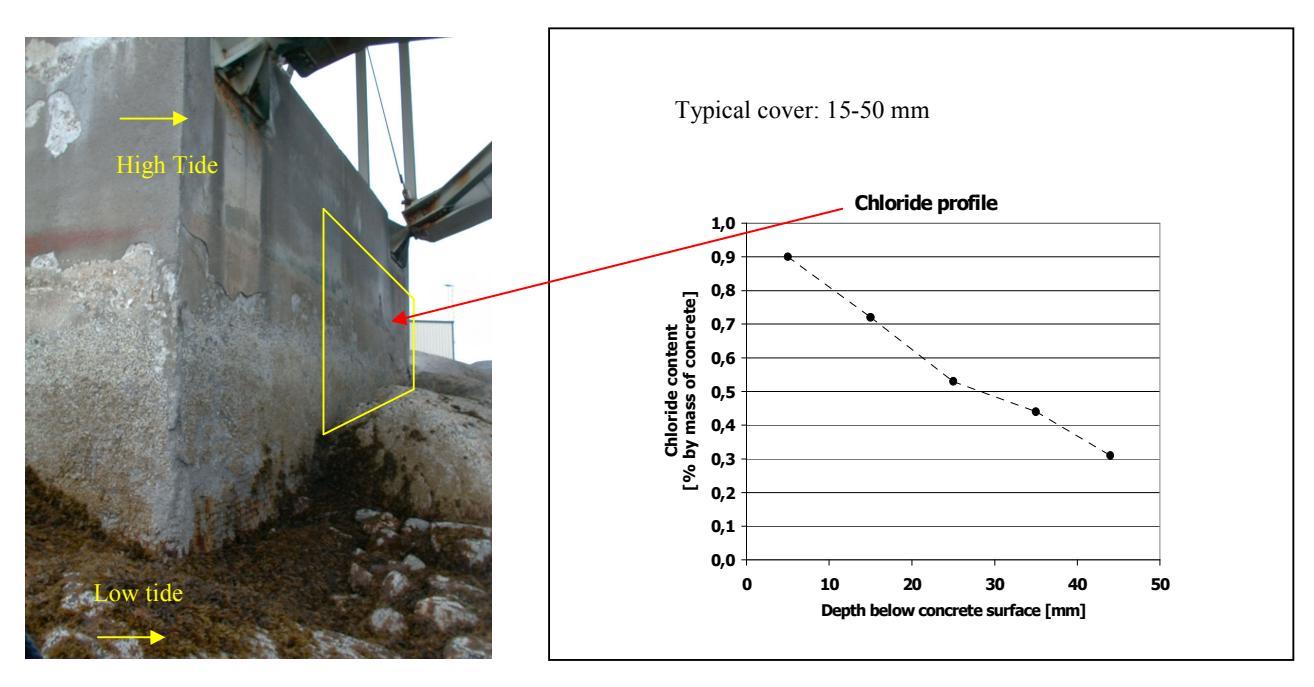
Fig. 5. The investigated area and the location of the chloride profile.

The next two examples are from a bridge foundation and a bridge deck in Greenland. The foundation was investigated in the tidal zone as shown in fig. 5 [6].

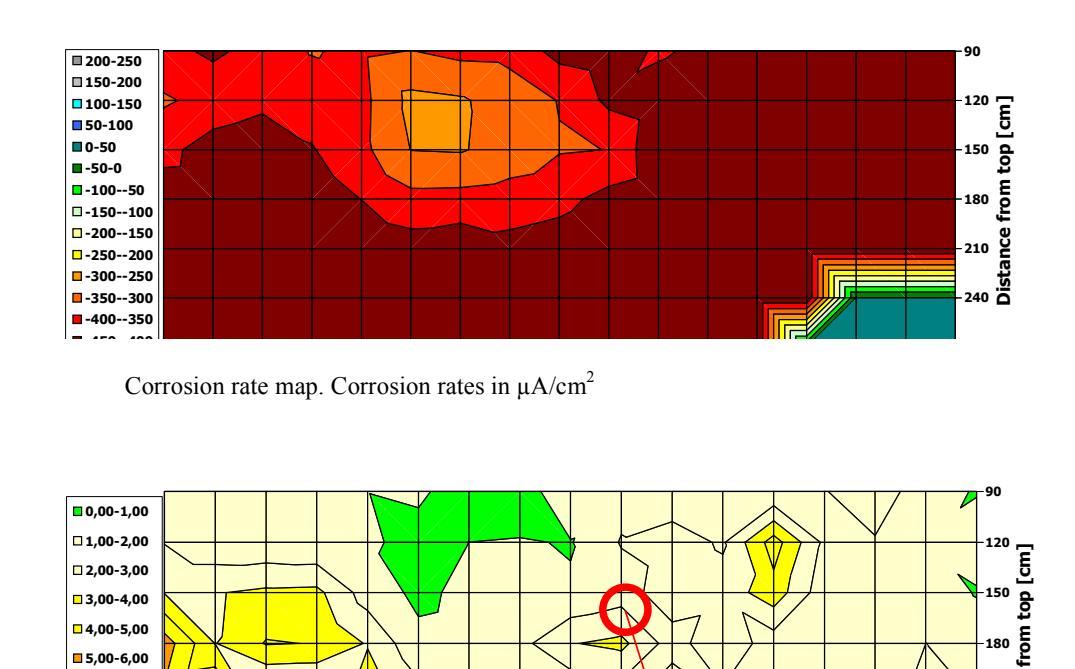
Half cell potential map of bridge foundation. Potential in mV vs. Ag/AgCl

Fig. 6 HCP and I_{corr} of bridge foundation

The chloride concentration in the depth of the reinforcement is in the range between 0,3% and 0,7% of the concrete weight. As indicated by the half-cell potential measurements corrosion should therefore be expected. However the measured corrosion rates are low and the verification by visual inspection (fig. 7) shows no damage to the reinforcement.

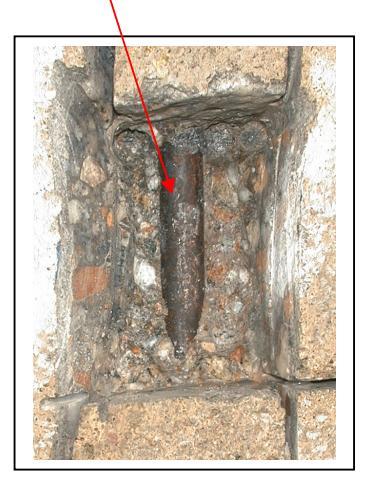
Fig. 7 Foto of break-up

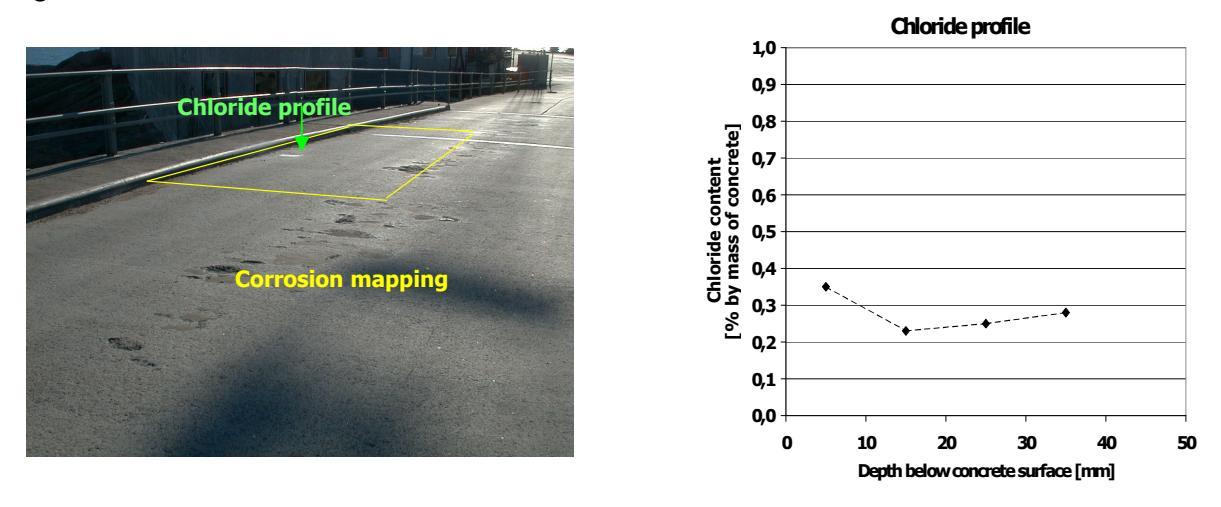
Fig.8 The investigated area and the location of the chloride profile.

The bridge deck from the same bridge in Greenland showed very different results as shown on fig. 8 and fig. 9.

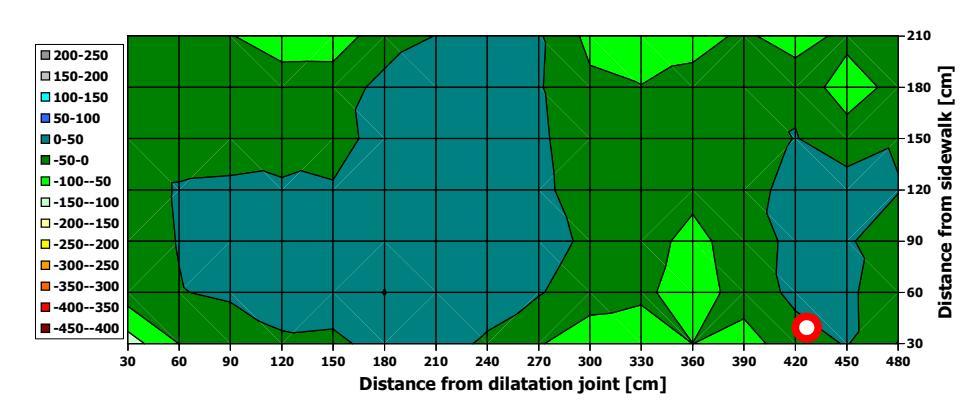
Half cell potentials in mV vs. Ag/AgCl reference electrode

The typical dept of the reinforcement is here minimum 40-50 mm and the chloride concentration in this depth is near 0, 3% of the concrete weight. At this high chloride concentrations the half-cell potentials are expected to be low but the most negative values measured are all above -100 mV vs. Ag/AgCl (fig. 9).

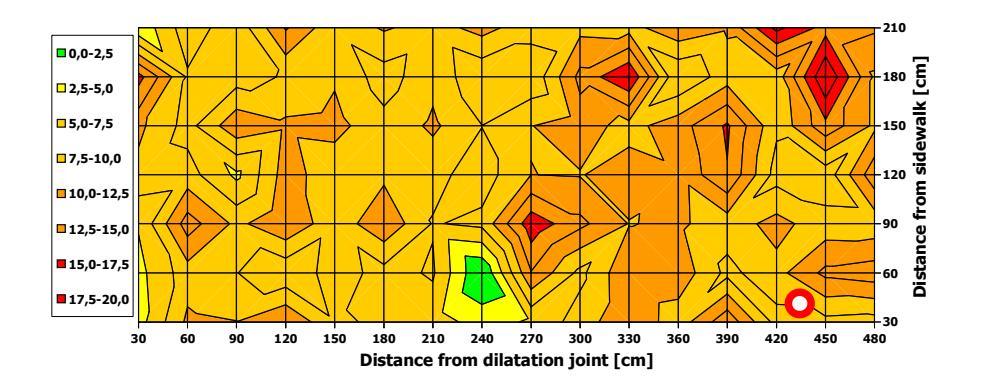
Corrosion rates in µA/cm²

Fig.10. Corrosion rate of the bridge deck. The read circle indicates the location of the chloride profile and the break-up shown at fig. 11. The photo in fig 11 shows the reinforcement covered with a thin layer of corrosion products. The ribs at the reinforcement are still intact but corroded.

The corrosion rate map fig.10 shows a completely different picture and indicates active corrosion at several locations.

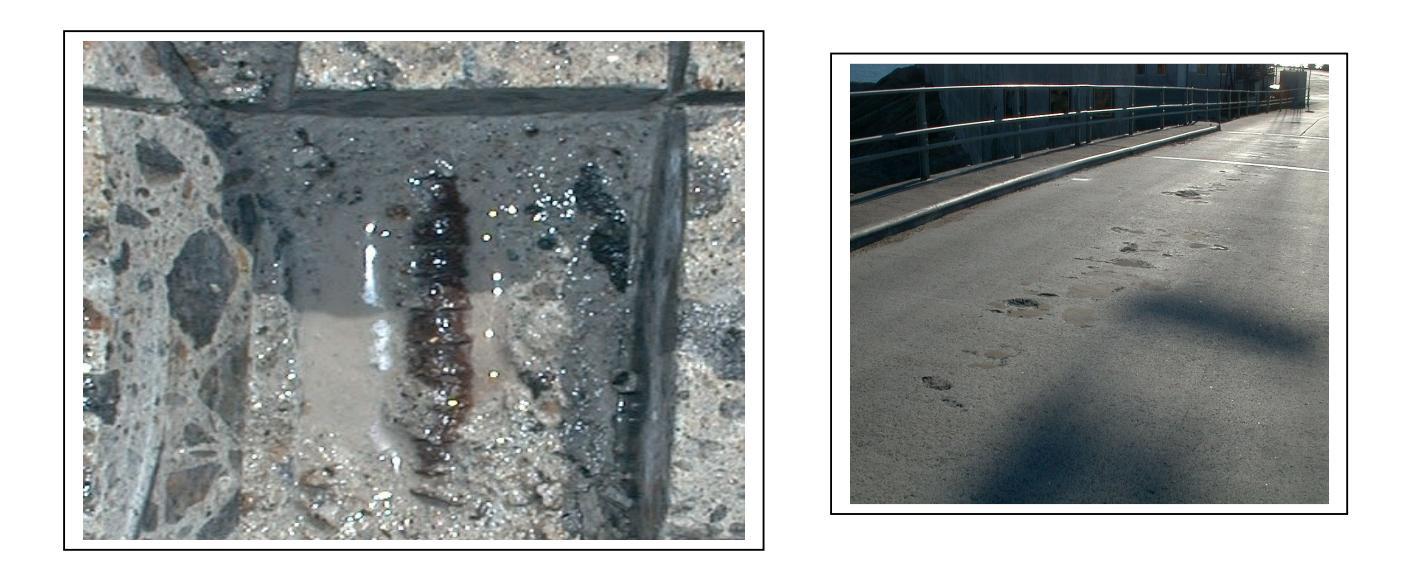
Fig.11. The first picture shows the corroded reinforcement and some water from cooling the diamond cutting blade. The second picture shows the damage and the mortar repairs.

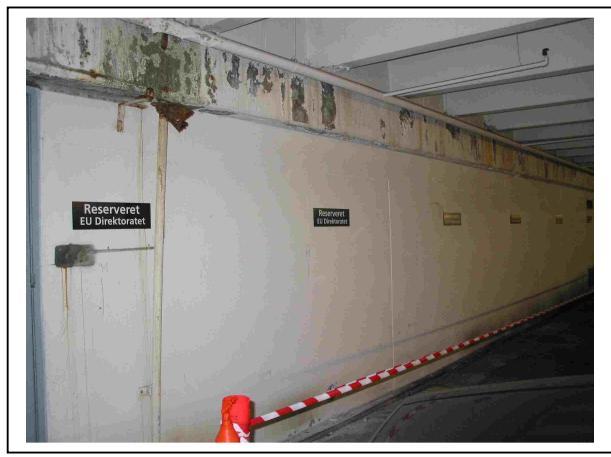
Fig. 12. Leaking of water and de-icing salts cause scaling of coating.

The last example is an underground car park in the Copenhagen area. The rather constant temperature is around 15 °C during the whole year. Most of the observed damages are due to the leakage of water/deicing salts from the street above. Also de-icing salt from the parked cars in the winter causes damage to the walls near the floor. The concrete was very dry during the investigation. The walls were surface treated with the protective coating. At the locations where water was leaking into the construction the coating was scaling (fig. 12.)

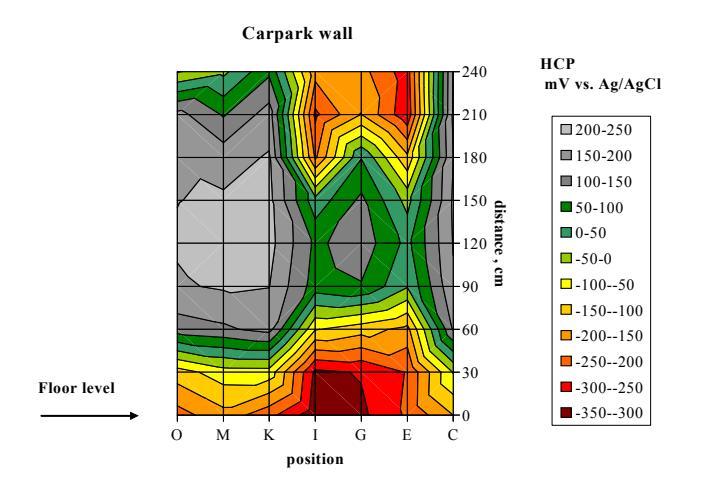
The HCP measurements from a typical area of the wall are presented in fig. 13.

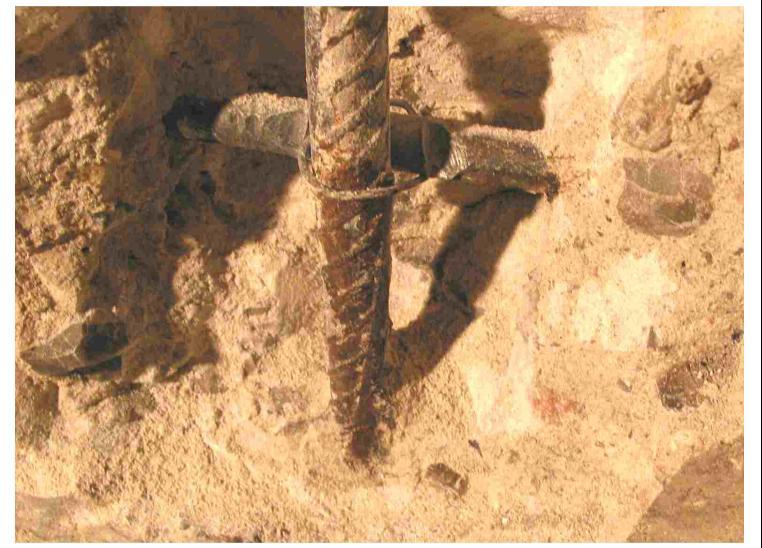
Fig.14. Exposed reinforcement at floor level in car park wall where HCP show very low values.

By galvanostatic pulse measurements the actual corrosion rate in the position between I and G at floor level was estimated to be $0.9 \ \mu A/cm^2$. The picture (fig. 14) shows some corroded area but no cross section loss and the tie wire is intact. In this example both HCP and GPM measurements point out places

with active corrosion. The rather low corrosion rate is in good correlation with the cross section loss observed while the low half cell potentials indicates a high risk of high corrosion activity.
